## Reasons for Reflector Replacement

# Timeline for Reflector Repair

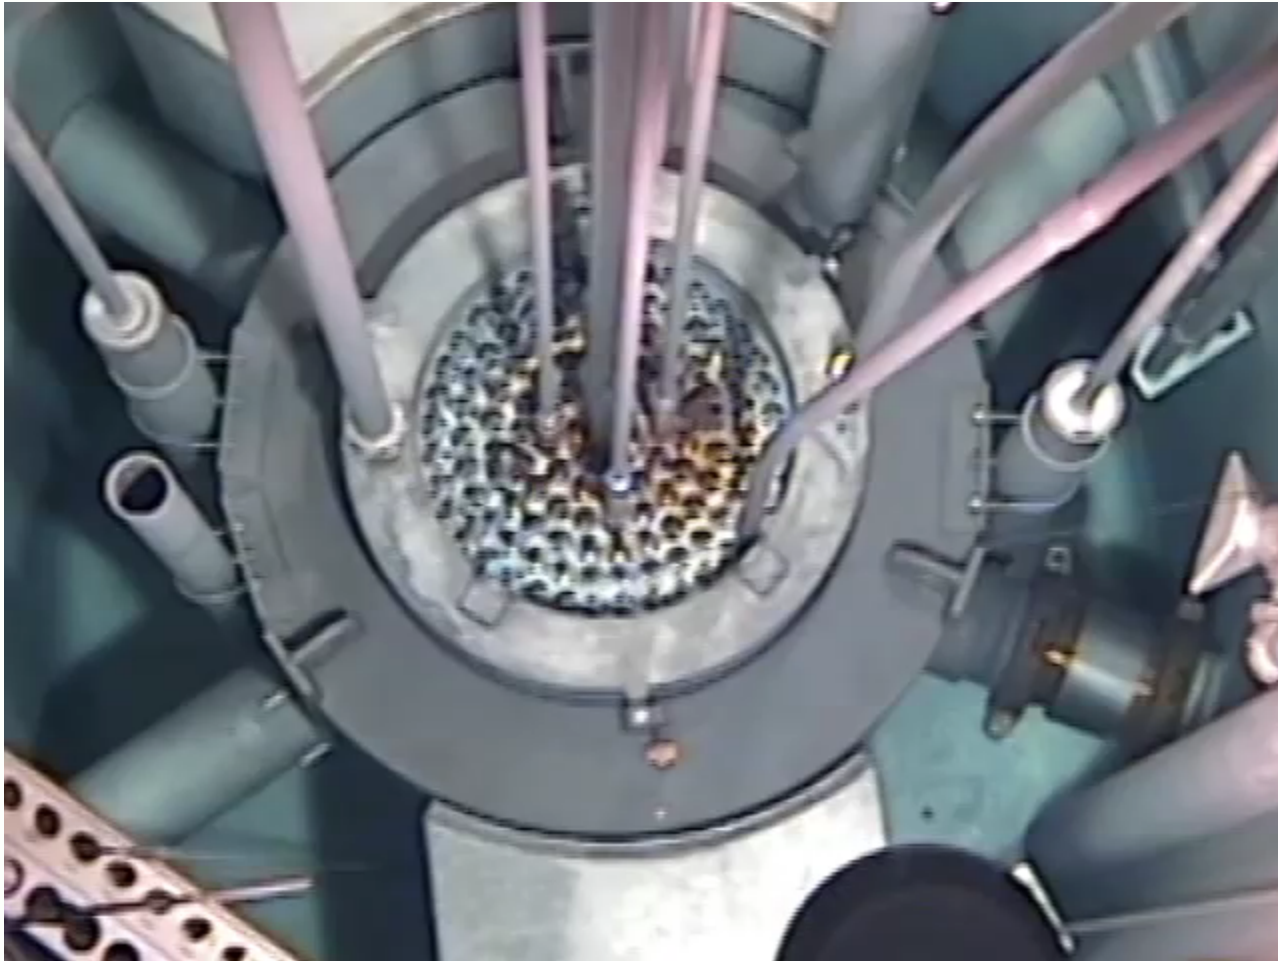
- After 40 years of operation, reflector began experiencing water in-leakage, culminating in a breach on 7/31/2009
- Water-saturated graphite and water-filled voids caused flux depression in beam ports and thermal column facilities
- Previous reflector design had solid graphite in front of beam port #2 significantly reducing the thermal neutron flux

## Evidence of Reflector Breach at 1 MW

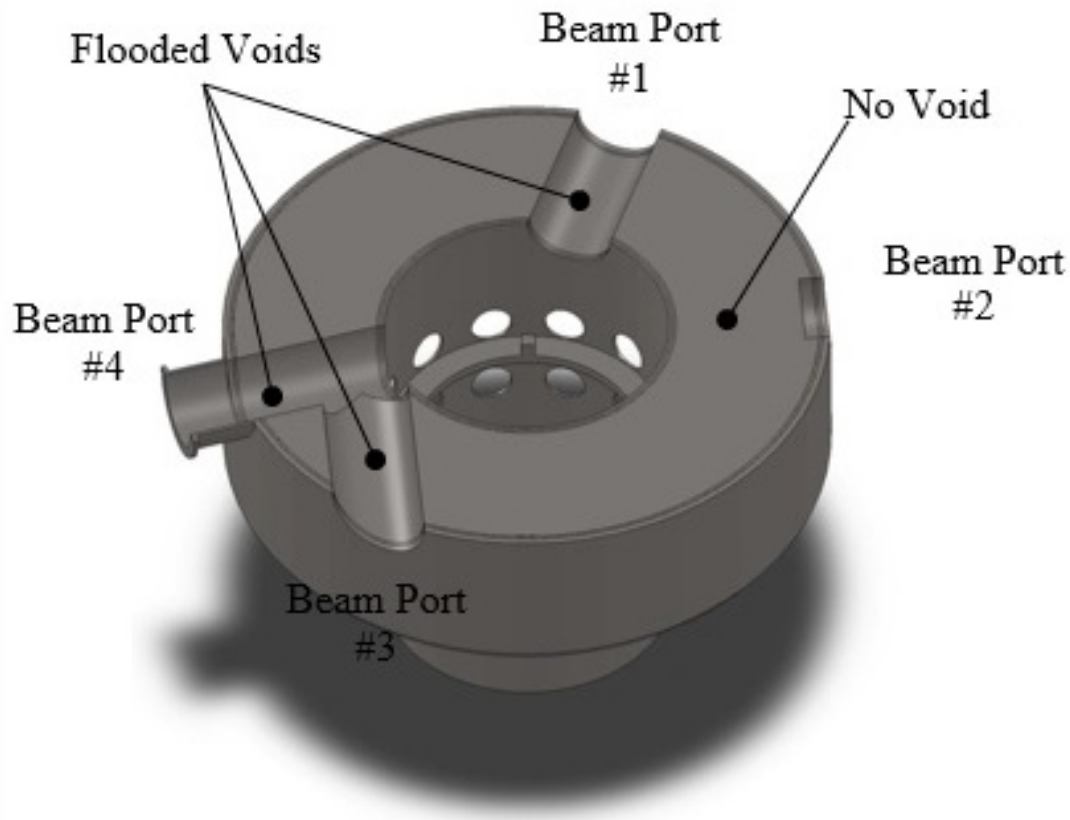
# Old Reflector Design

- Original reflector had voids in graphite, which eventually filled up with water, precluding flux
- Beam Port #2 facility had no void in graphite, severely reducing the potential thermal flux in that facility
- New reflector fixes these problems by placing sealed aluminum cans within the graphite gaps in beam ports #1, #2 and #3

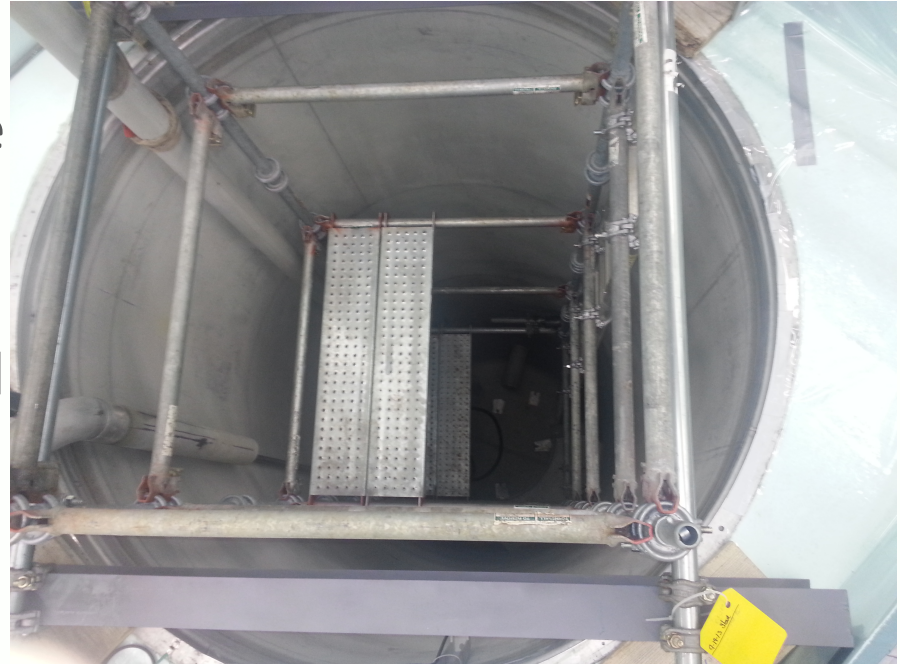
# October 1<sup>st</sup> – Tank Inspection

- Scaffold was installed in order to perform a complete tank inspection
- Ultrasonic thickness tests were successfully performed up to the lowest scaffold level (~10 ft. from bottom of tank), no degradation found
- Remote tank inspection was performed with HD cameras near the tank bottom due to high radiation levels
