# **A Brief History of the NRU Reactor Vessel Leak and Repair**

TRTR Conference

G.B. Wilkin

2010 September 19-24

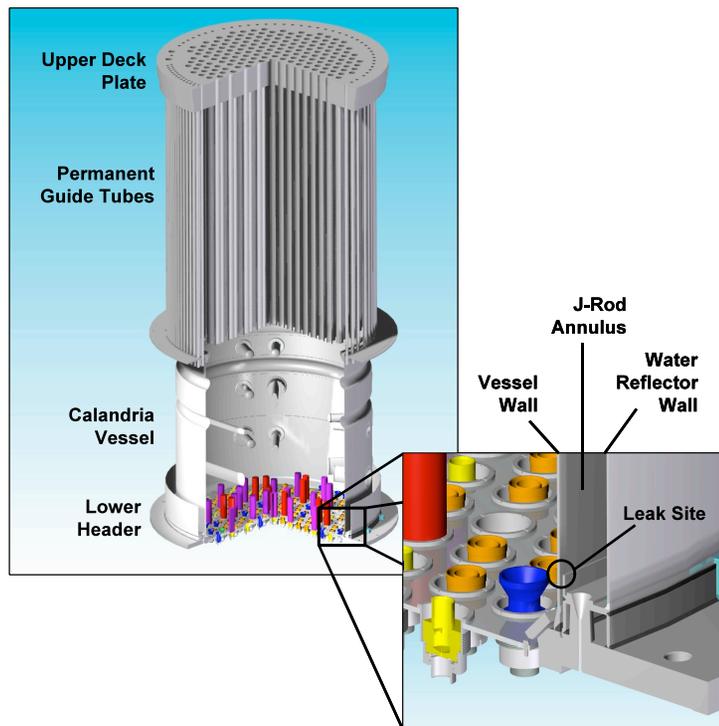
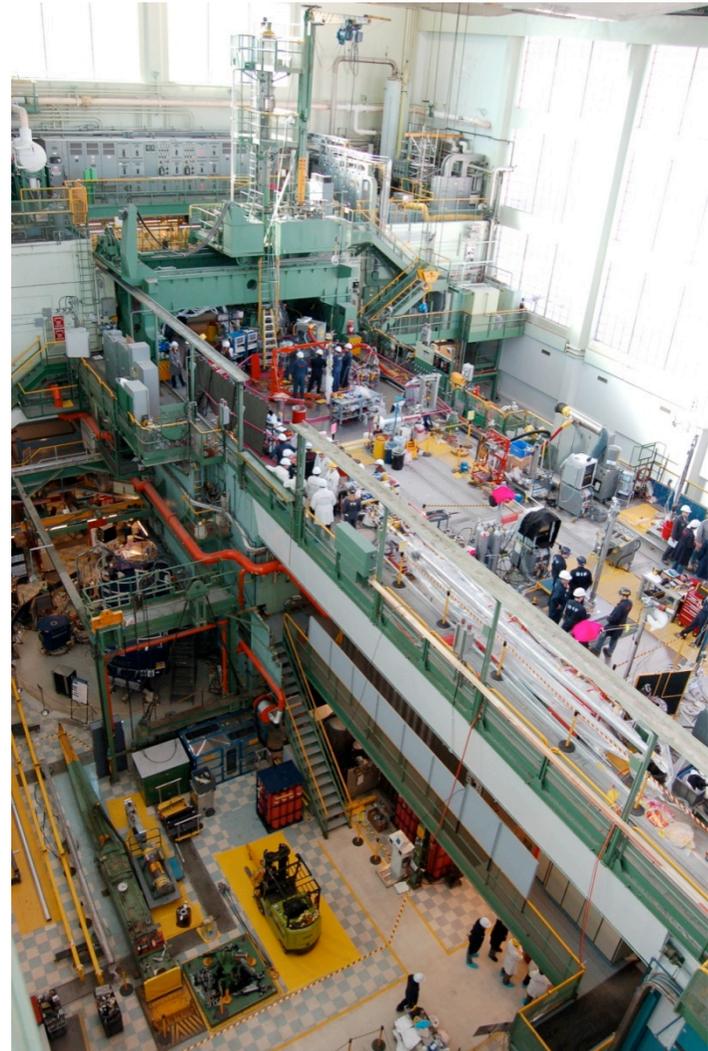
# Location of Heavy Water Leak

- Leak site is 30 feet below the deck plate at the base of the vessel
- Access through 4.75-inch dia. tubes
- High radiation environment

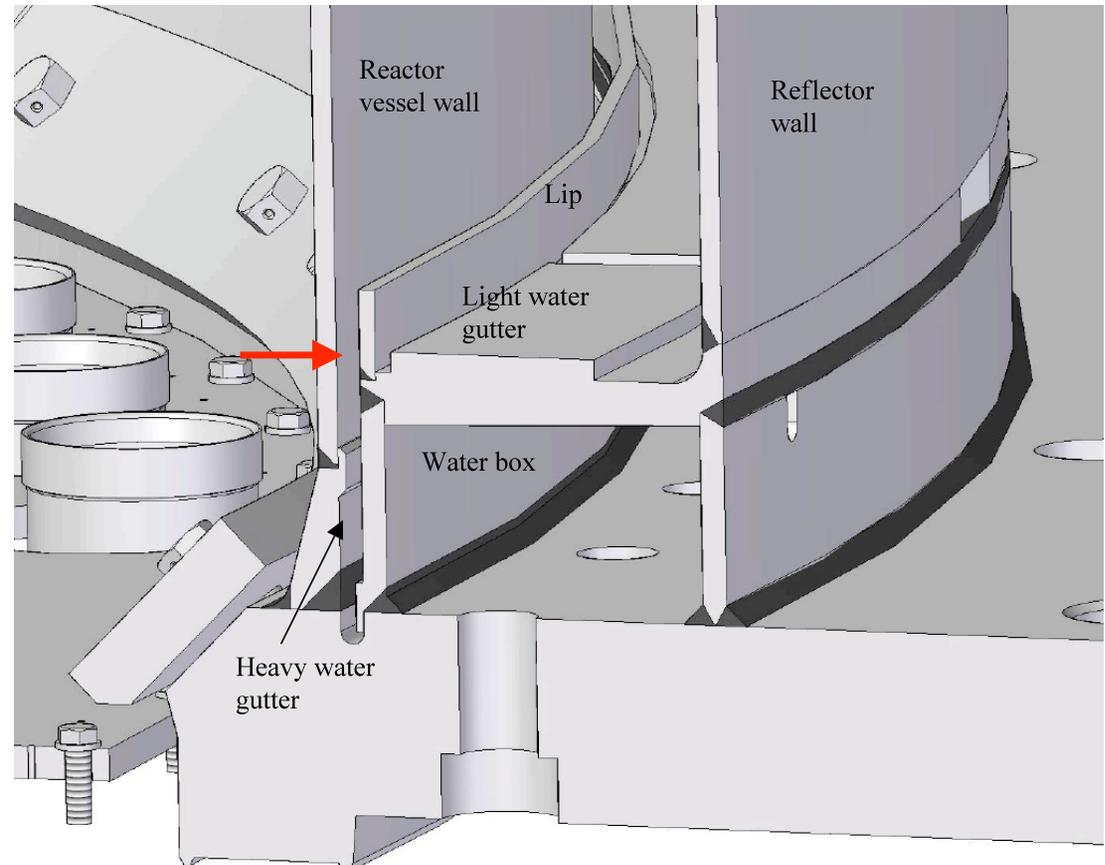
# Leak Site

- Detailed non-destructive examination of lower vessel wall performed
  - Leak location determined accurately
  - Corrosion widespread in the lower portion of the J-rod annulus

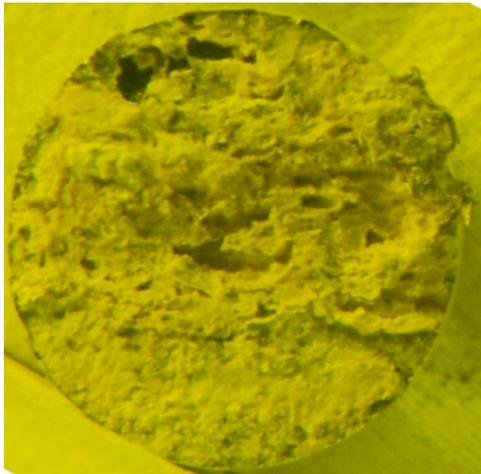
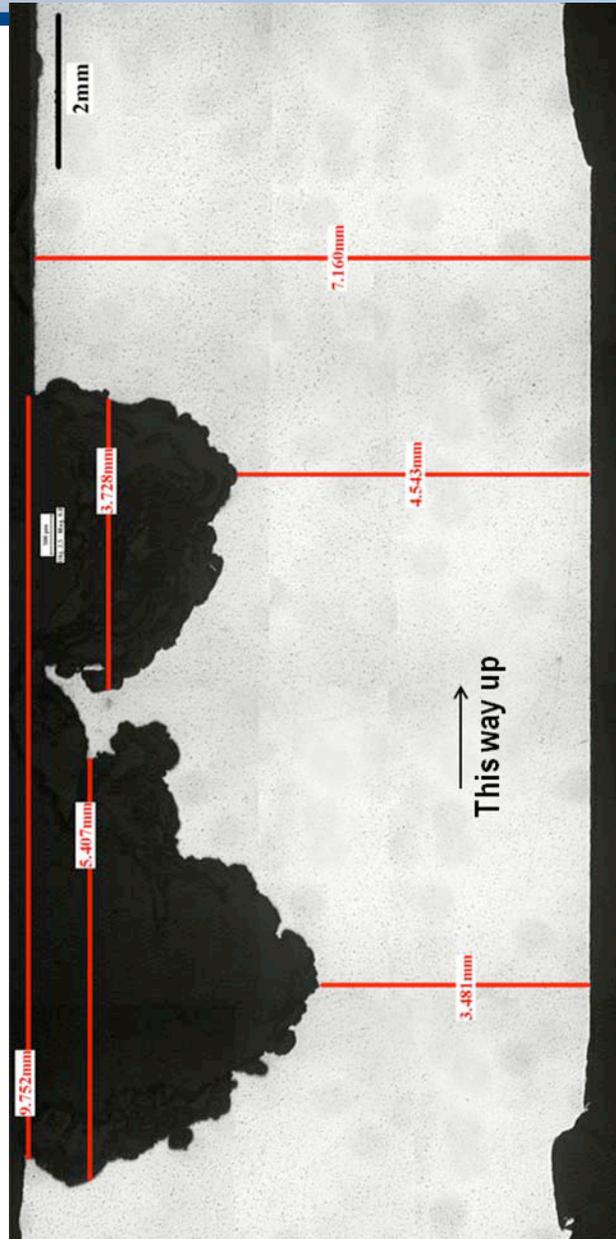
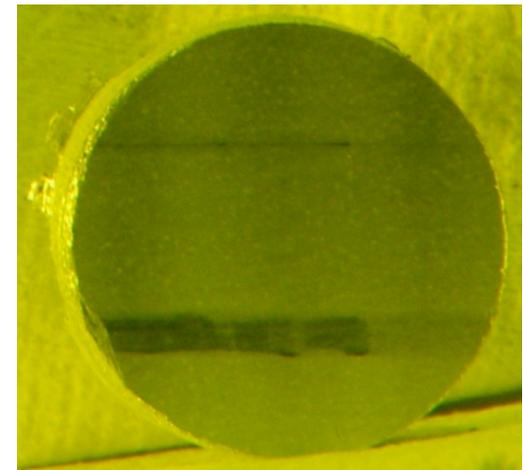
# Removed Coupon from Vessel Wall

- Several mechanisms have been suggested to account for the localized pockets of corrosion
  - Material properties
  - Additional impurities (e.g. copper contamination)
  - Thermally induced nitric acid concentration mechanism
  - Localized corrosion cell enhancing nitric acid corrosion
- Enhancement of nitric acid corrosion mechanism by either concentration of the acid or formation of an electrochemical cell currently favored based on detailed examination of removed samples
  - No materials changes
  - No contaminants found
  - Nitric acid found in corrosion deposits
