THE UNIVERSITY OF UTAH

UUTR Modern Reactor Control Console Upgrade

*By Amanda Foley, Glenn Sjoden, Meng-Jen "Vince" Wang,
Andrew Allison, Edward "Ted" Goodell*

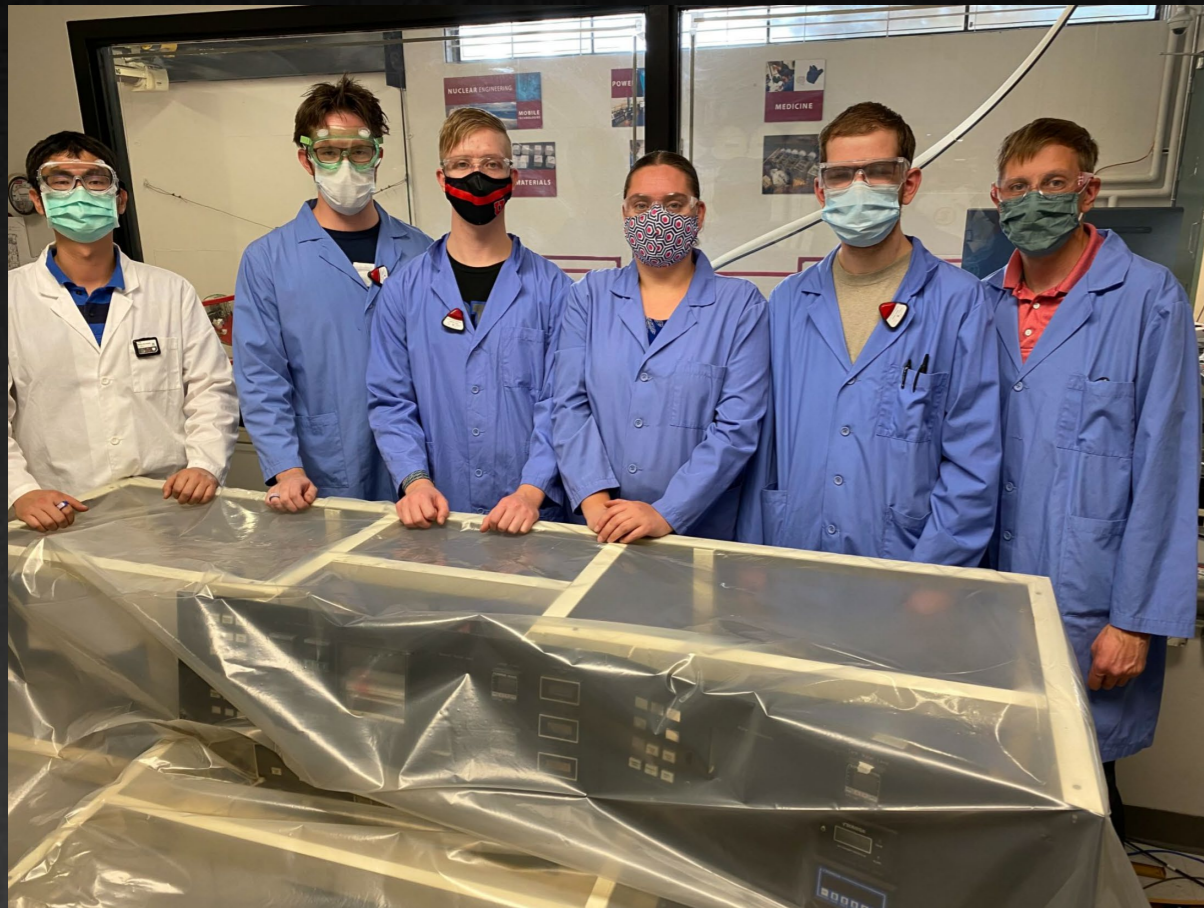
Mark III Console Removal

- Labeled and unplugged all support equipment from console
- Expected to be a simple “pick it up and move it process”
- Door frames where too small to move console through in one piece
- Console table section was removed to fit through the doors
- Sent to recycle

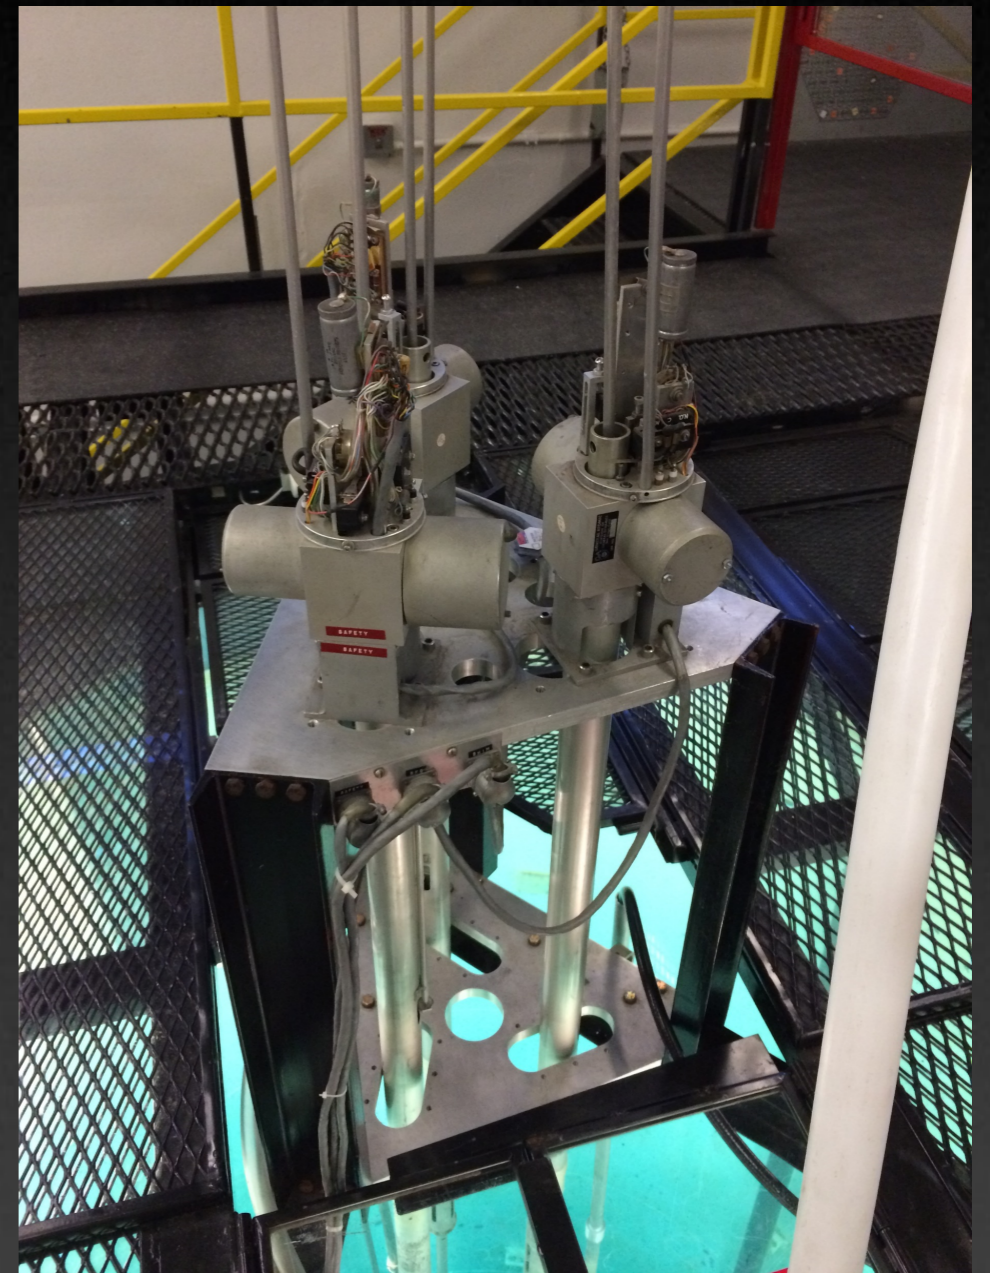
- Wiring diagrams did not match in service wiring.
- Attempting to integrate the Regulating Rod into the ThermoFisher console resulted in damage to the Auto Rod Control Board due to wiring fault.

- High voltage and low voltage were together on the same Amphenol connection
- Wire tracing was nearly impossible due to undocumented rewire
 - e.g... ten-turn potentiometer wiper wire was either moved or completely removed

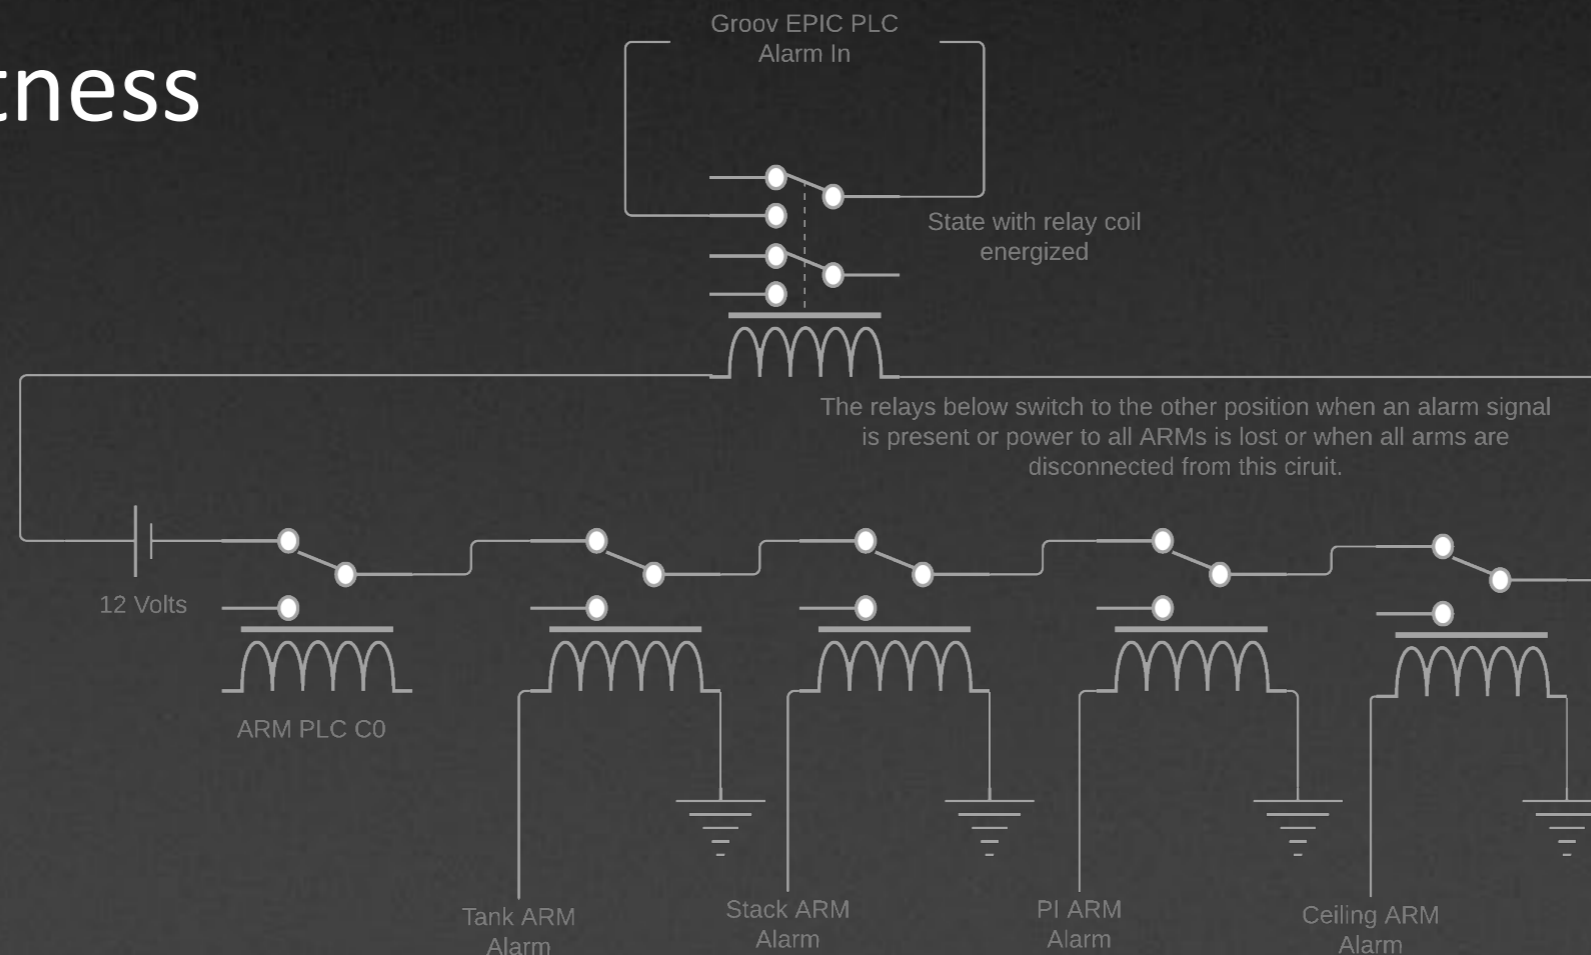
Area Radiation Monitor Issues

- Televue and the Direct Logic 205 PLC would not always communicate the signal that switches the alarm relay state
- High rad alarm from detectors added to alarm loop for robustness

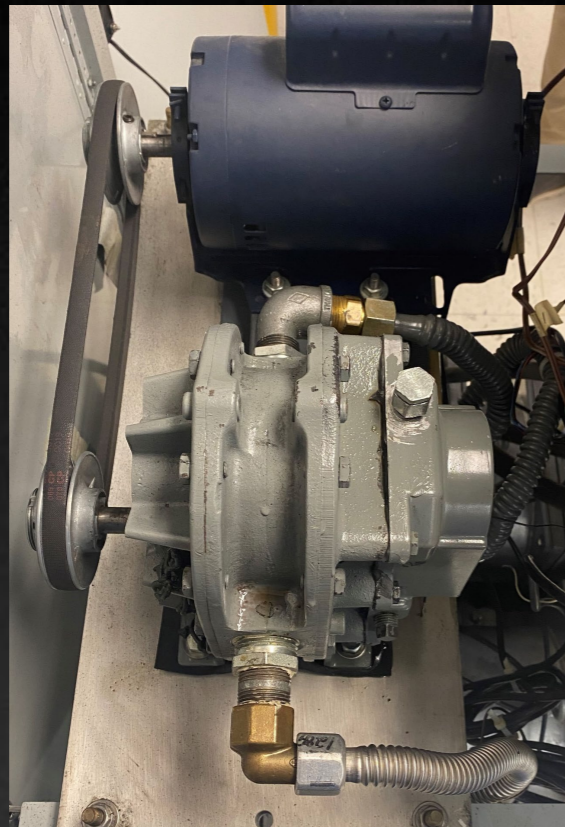
Old
Blower

- CAM Blower was leaking / not serviceable
- The CAM blower Universal RAI blower model 22U-RAI was replaced with a Howder Roots blower model 22U-RAI.
