# MIT NUCLEAR REACTOR LABORATORY

## Re-starting from scratch: Waking up MITR II Nuclear Instrumentation

# MIT Research Reactor (MITR-II)

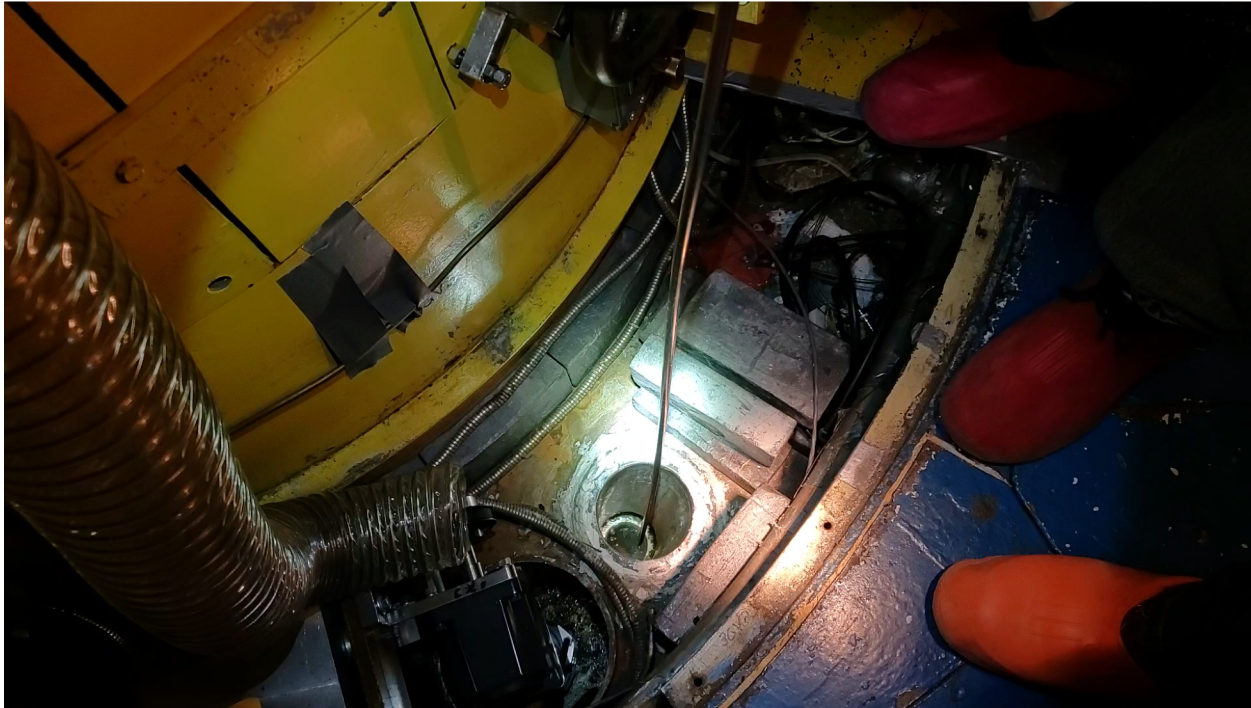
## ➤ Dec 14 2022- Vertical Port view

- Vertical port plug removed, flooding of vertical ports confirmed
- There's not supposed to be primary coolant there
- Disassembly and leak discovery process begins

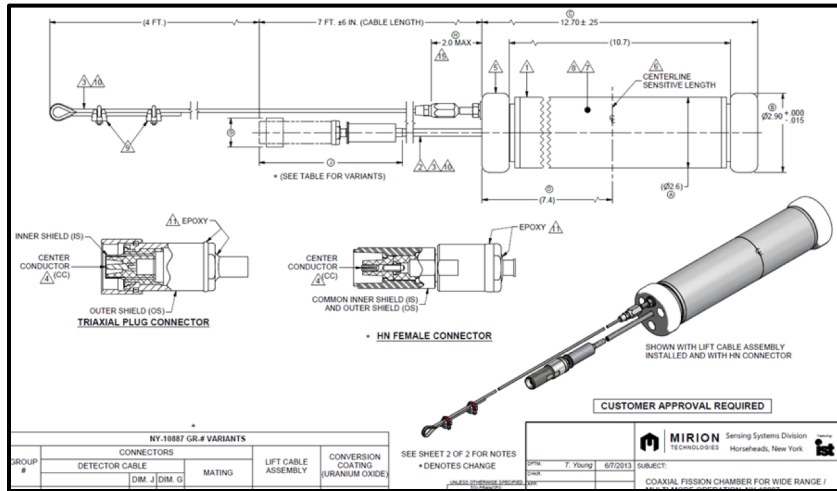
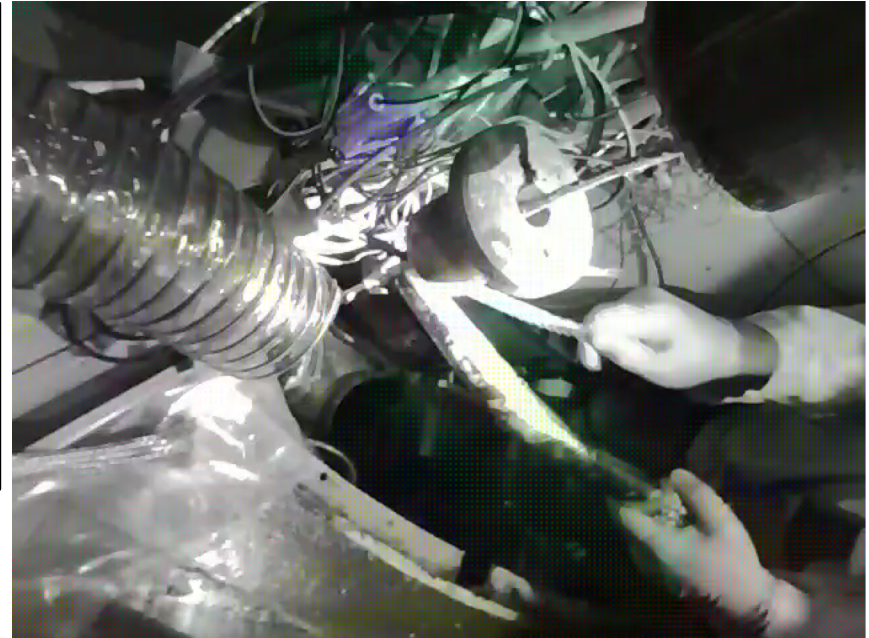
- As it turns out while our fission chambers are hermetically sealed, they are not intended to be submersible
- Vertical instrumentation port filling with water results in bonus neutron moderation, reduction in apparent flux.
- Fission chamber MI Cable damaged from extended moisture
  - One vertical Nuclear Safety system detector failed due to corrosion

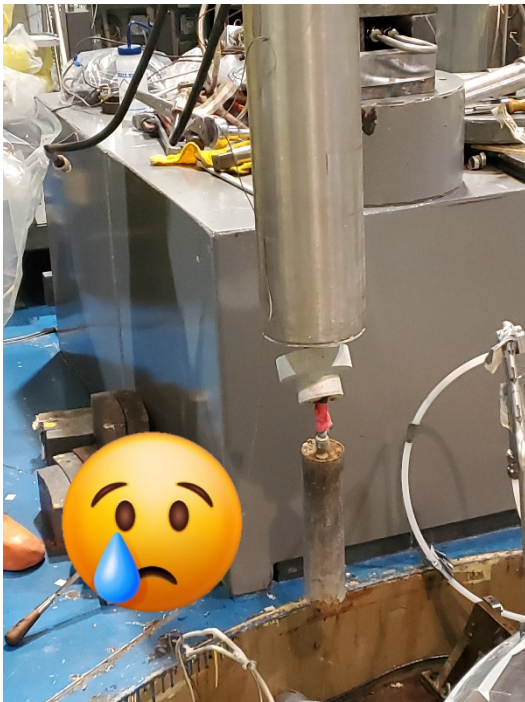
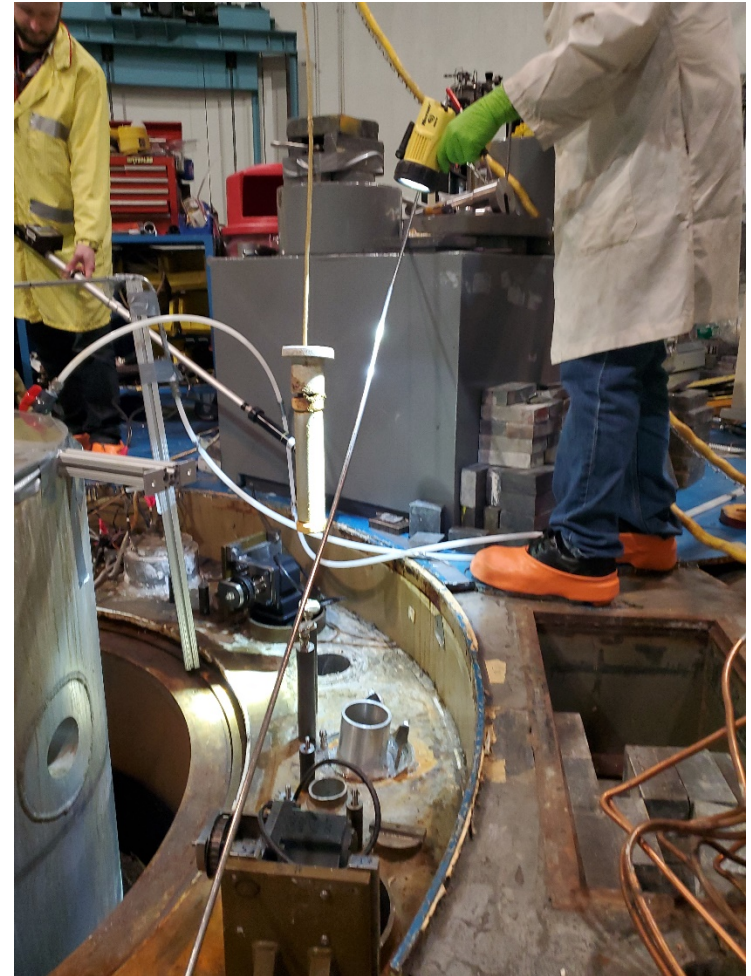
- Fission chamber directly exposed to water showed signs of cable failure
- Linear Flux chamber with top mounted connectors comically corroded

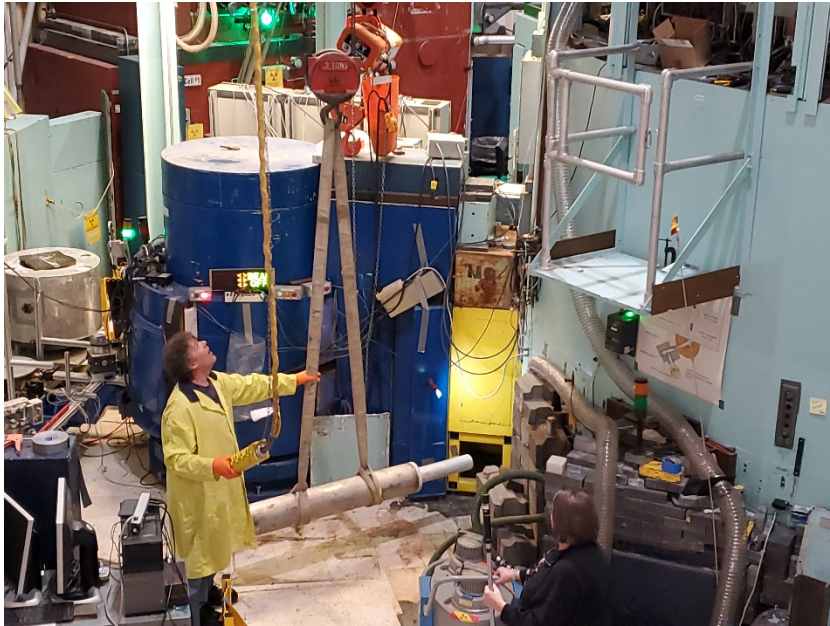
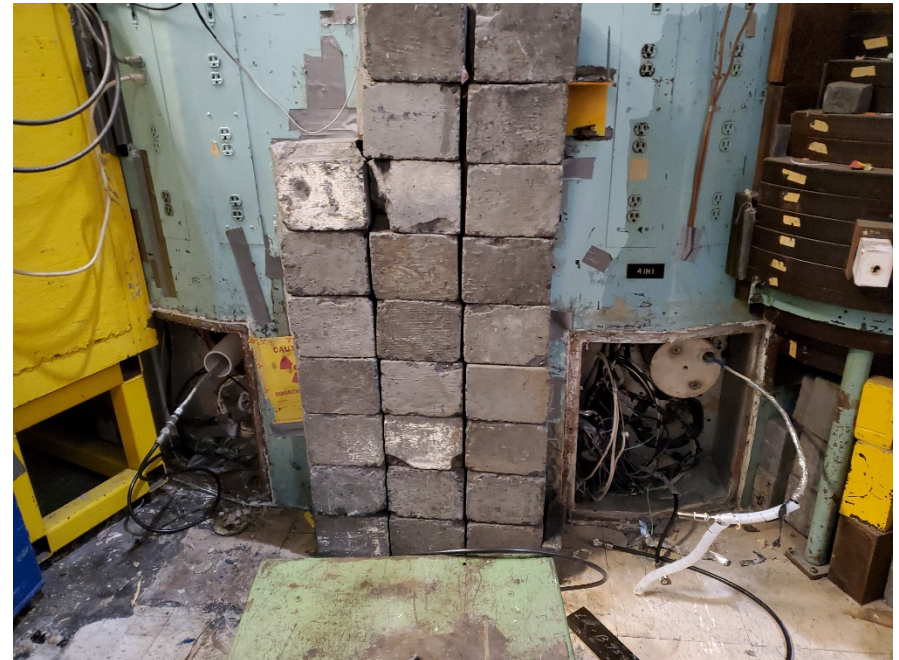
- Existing port plugs purposely restrict detector location

- To re position detectors closer to fuel, cable extensions fabricated
- Horizontal detector port tubes sleeved with PVC to limit resistance when re positioning detectors

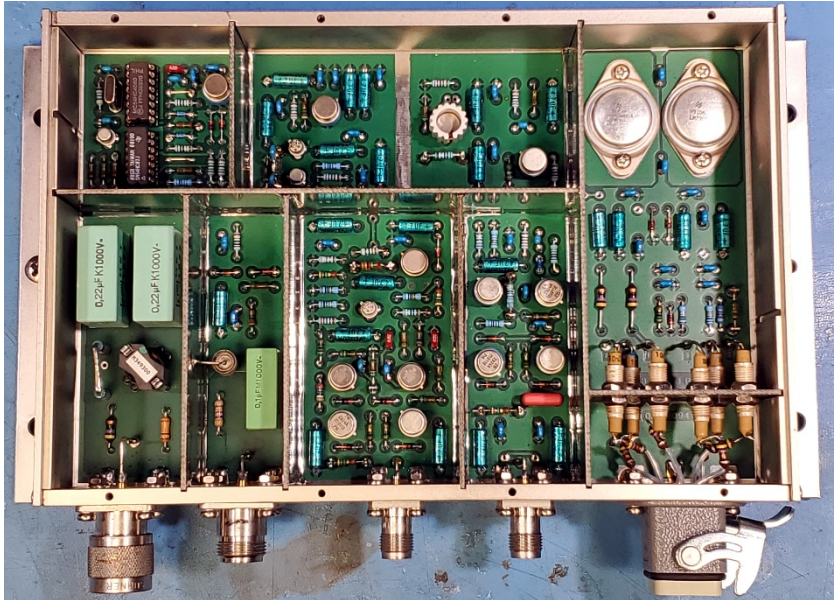
Wide Range Preamp TKV 23

- Facility disassembly prioritized leak location identification
- Order of operations resulted in hardware issues
  - Significant damage to channel pre-amplifiers caused by disconnecting at detector in powered down state
  - In powered-down state, cable disconnection order appears to overstress internal component
  - 4+ Month lead time on replacement units

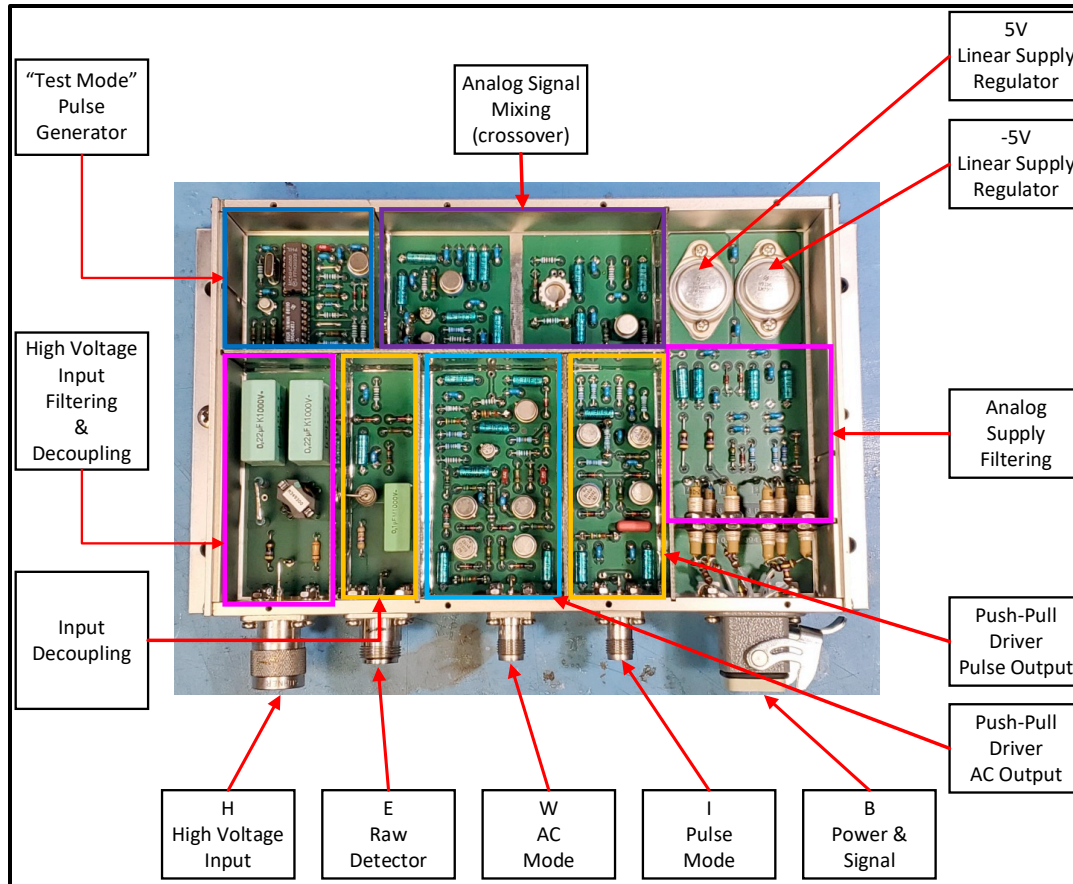
- Pre-amplifier uses no component reference designators
- A number of components are no longer manufactured
- Schematic & signal level repair unavailable
- Design is 2 layer allowing for easier reverse engineering
- Through hole components appear hand assembled

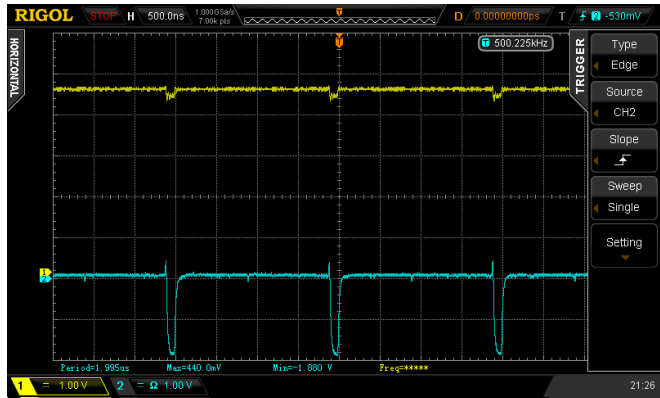
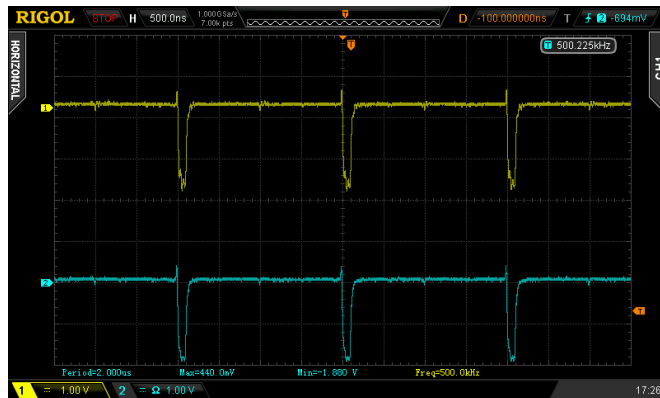
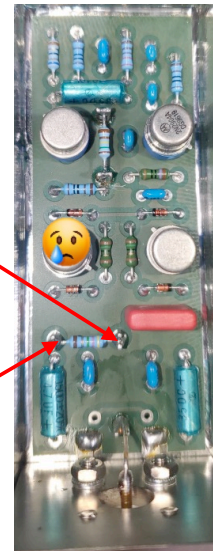
- Multiple units appeared to have similar failure mode, count-rate level pulse train generation
- Identical component fortunately replicable and available for purchase
- Failed push-pull output resulted in malformed pulse-mode signal
