Corrective Action Program at NIST

Randy Strader

10/1/2024

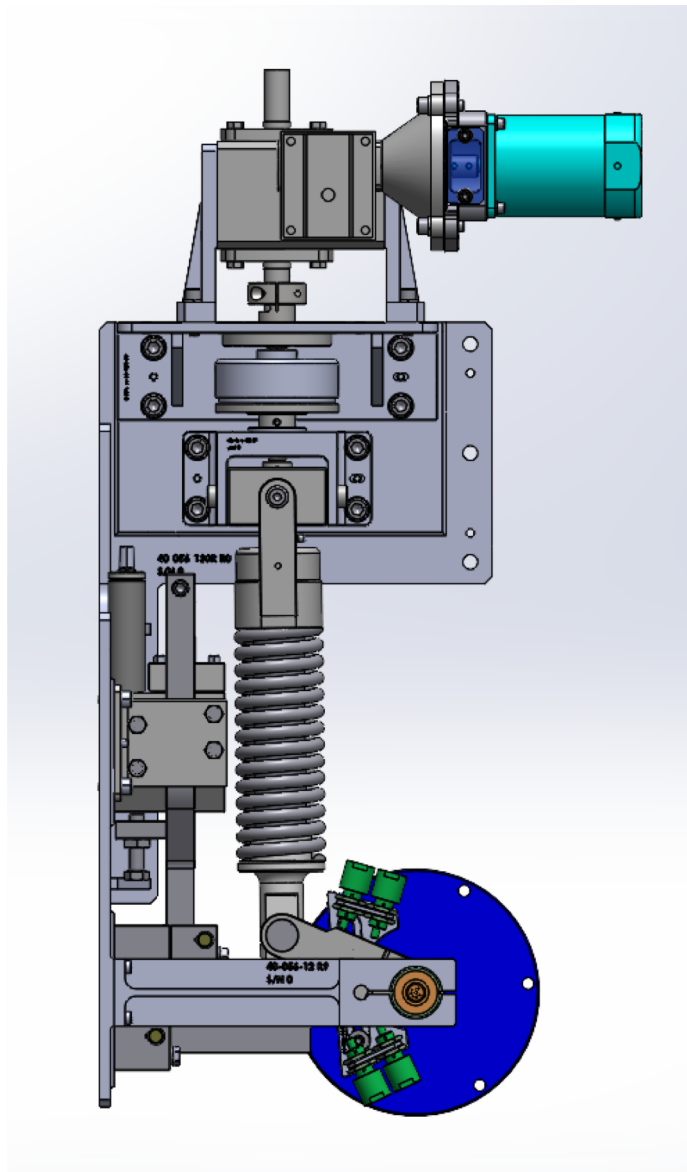
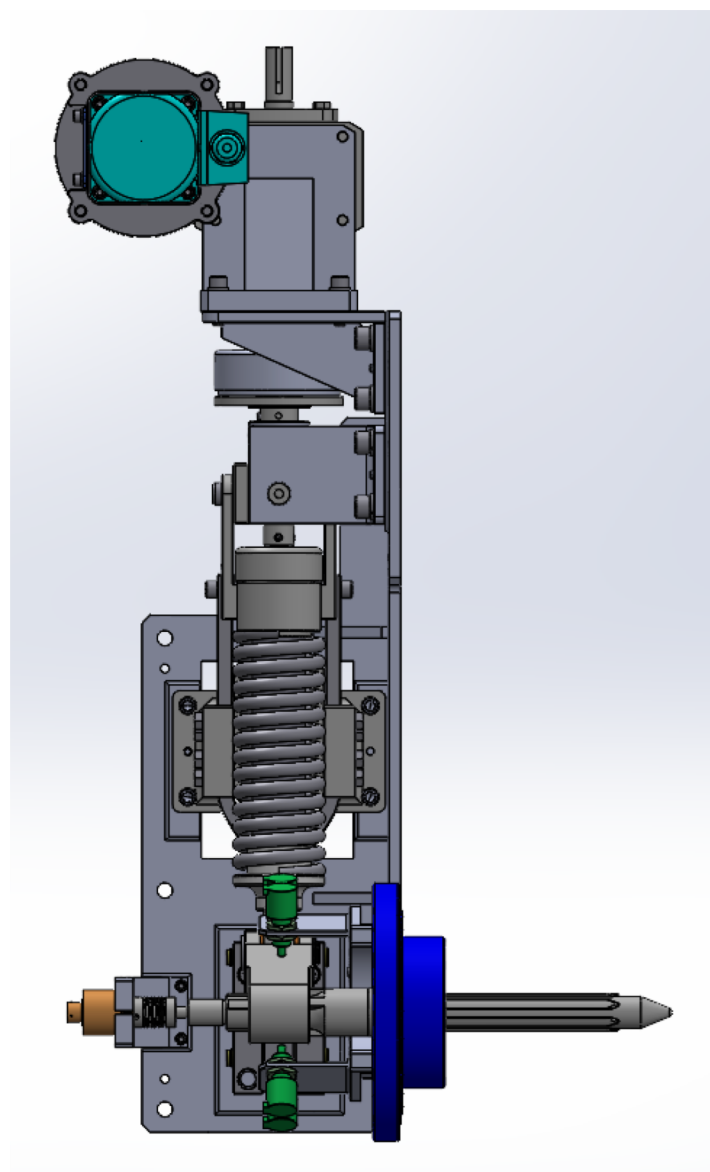
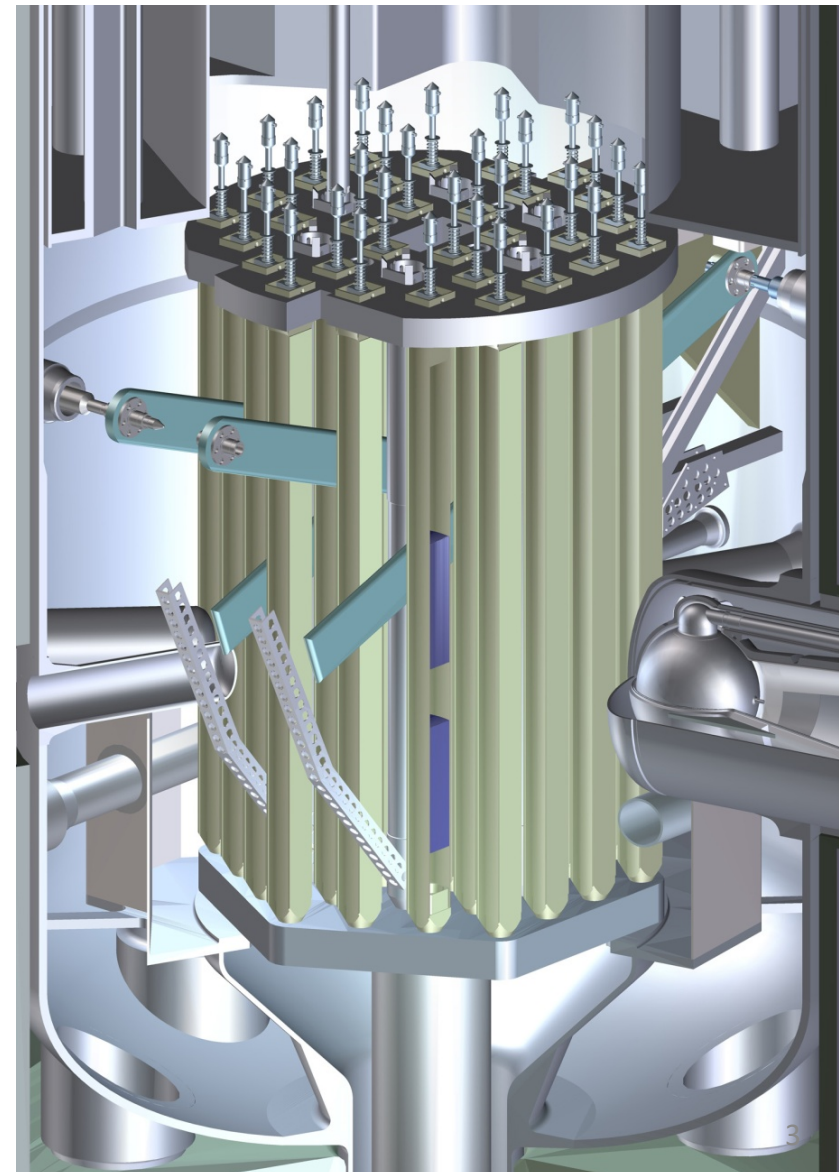
Shim Arm/Shim Arm Drive Mech...

- NBSR has 4 shim arms
 - Each arm has an independent drive mechanism
 - Controlled from the Reactor Console in either gang or individual mode.
 - Shim Arm Drives move at one constant speed in and out of core
- The new design would eliminate some common issues all 4 drives shared.
 - Position indicator potentiometer failure
 - Ball Screw binding/failure
 - Misalignment between Shim Arm Shaft & Drive
- Shim Arm Drives were a multi-year redesign effort

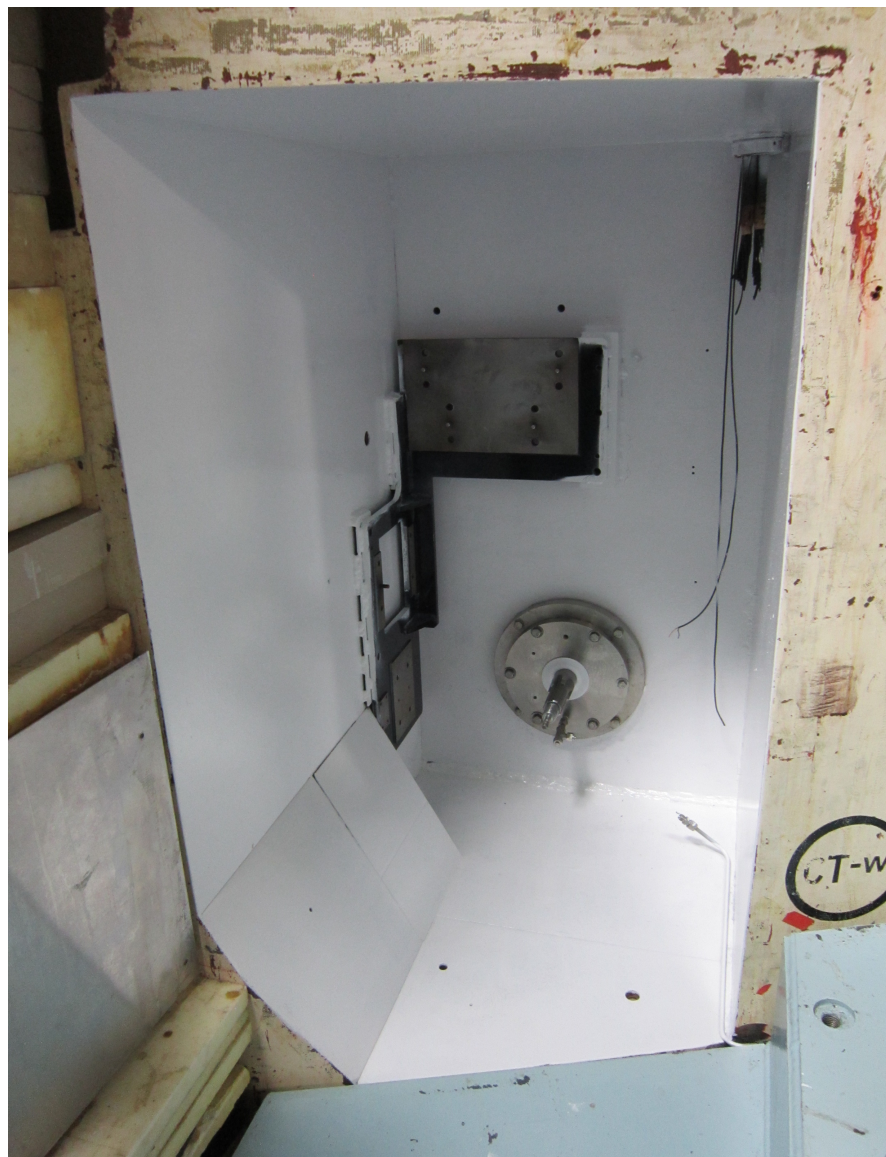
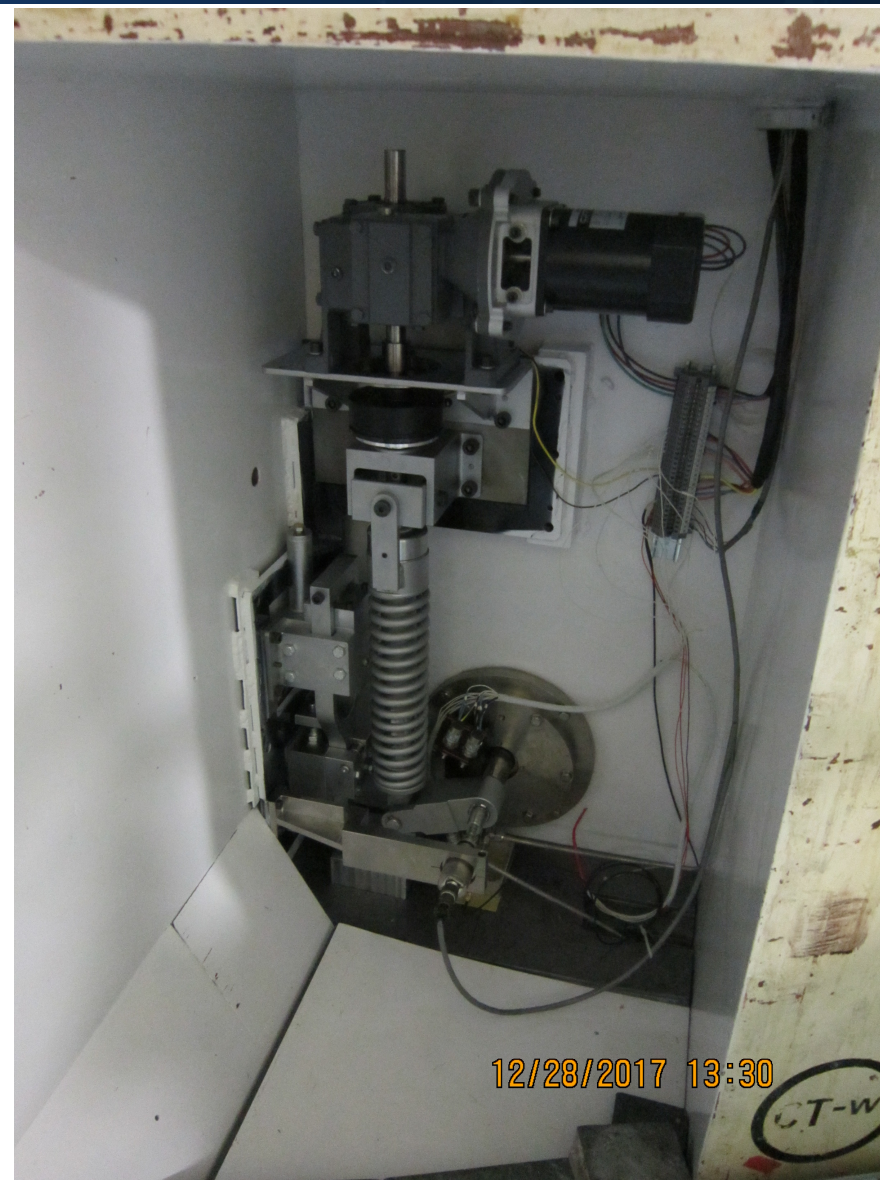
Refurbished Cavities

- Steel frame with pins designed and fabricated in house
- Frame installed in 3 steps
 - Arm bolted to frame to center installation on Shim Arm Drive Shaft
 - Tac weld and alignment re-checked
 - Finally, a skip weld of frame to cavity and final check of alignment

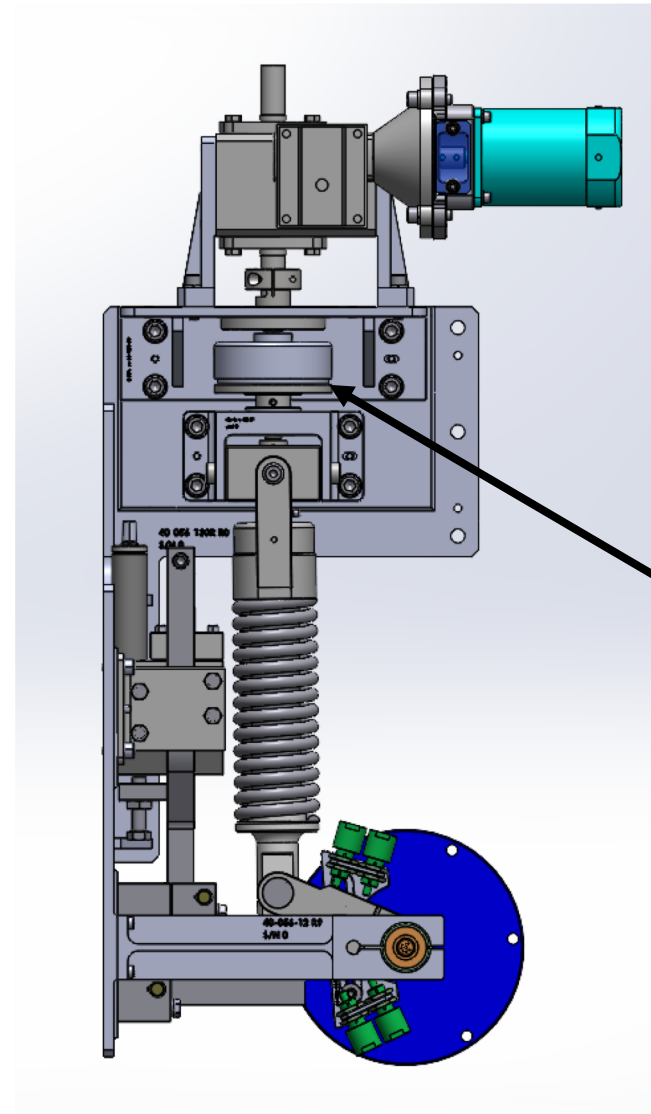
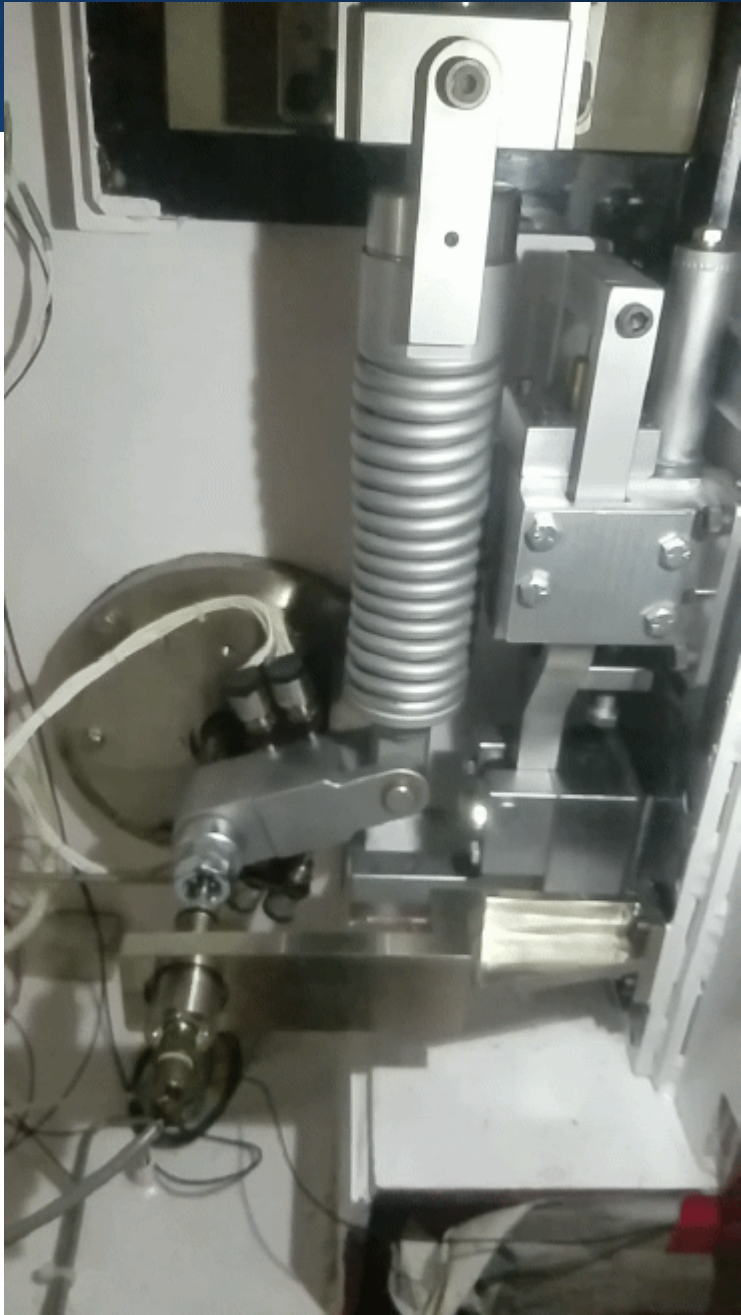
- Air gap is required in design to allow for TS required scram times
- $\sim .040'' - .060''$
- Gap begin closing in cavity 3 months after installation

Gap between
clutch plate and
magnet

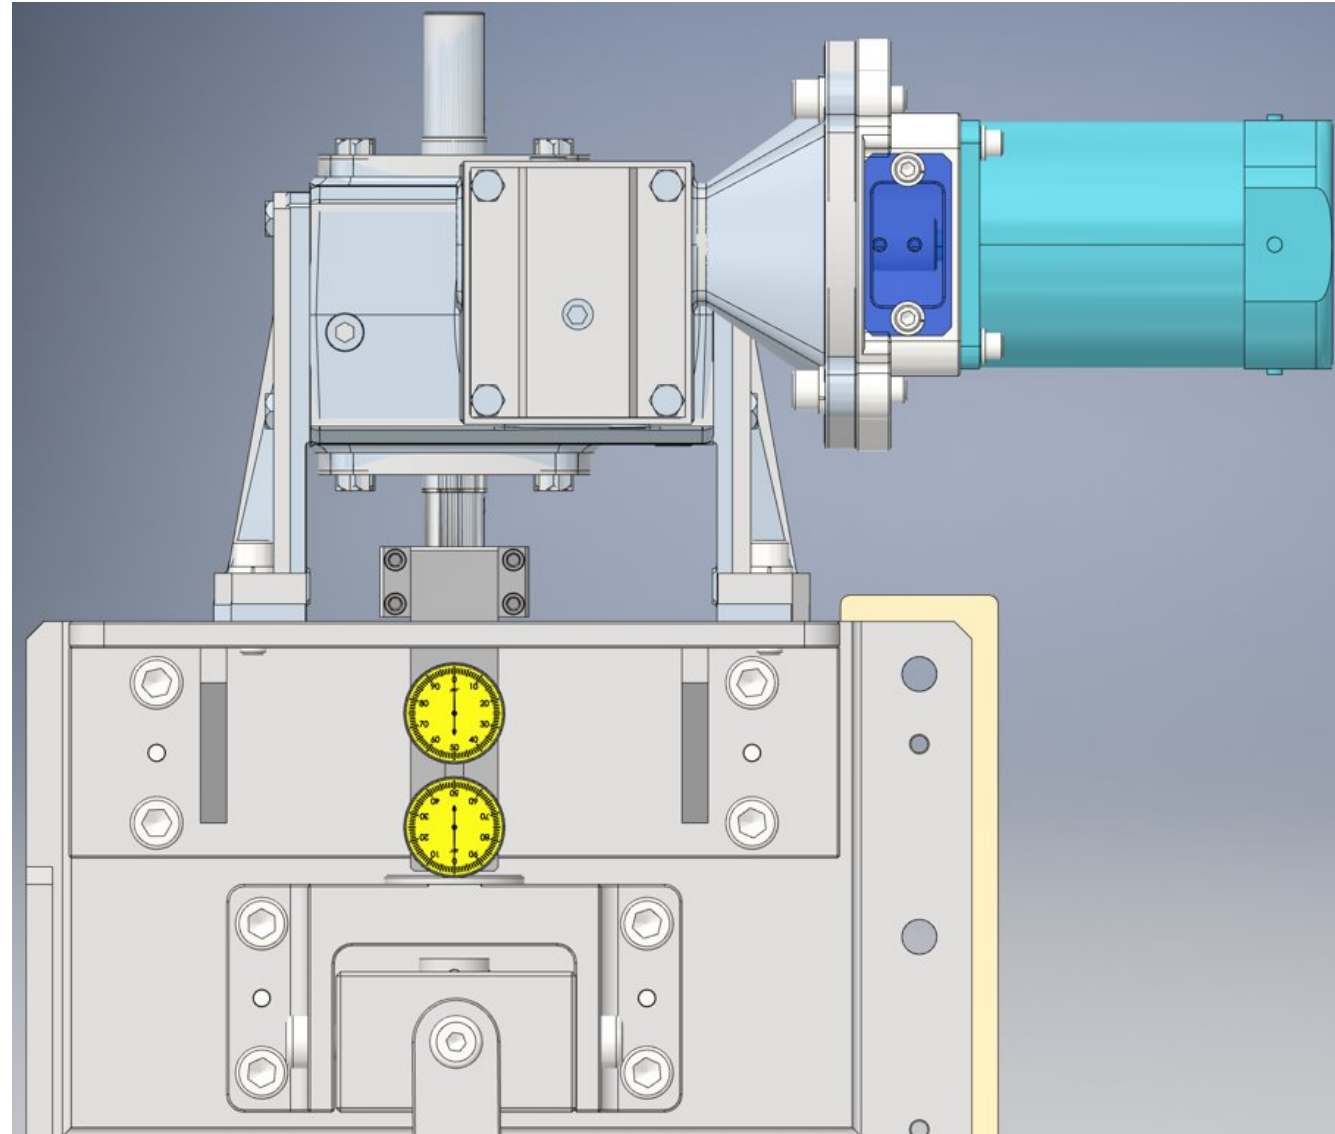
Corrective Action

+	1 Why?	After performing rod calibrations #3 shim clutch chattered upon a scram indicating that the clutch gap was below it's minimum value.
	2 Why?	It was observed that there was no clutch gap on #3 shim clutch.
	3 Why?	Further investigation showed that the hinged coupling had moved down the gear box output shaft closing the gap.
	4 Why?	Video of the shim movement confirms that the shaft is moving when the shim is moving. The oscillations observed in the video makes it evident that there may be an alignment issue between the gearbox output shaft and the lower clutch plate shaft.
	5 Why?	Alignment of the gear output shaft and the lower clutch plate shaft was out of the clutch specification.

Root Cause: The misalignment between the gear box output shaft and the lower clutch plate shaft caused the upper clutch shaft to move during normal shim movements.

Corrective Action: Align the gear box output shaft to the lower clutch plate shaft. See document "CAP 333 Shim Arm 3 Shaft Alignment"

- Alignment issue between the motor output shaft and upper clutch assembly
- Angular mis-alignment reduced to \sim zero^o
 - Fixed by shimming gear box feet
- Parallel misalignment \sim .010”
 - Fixed by rough adjustment of gearbox feet in reference to support bracket
