Diagnosing and Troubleshooting Successive Fission Chamber Failures

C. Corey Hines, Mathew D. King, and Donald E. Wall
Washington State University Reactor
Nuclear Radiation Center

Washington State University Reactor: Background

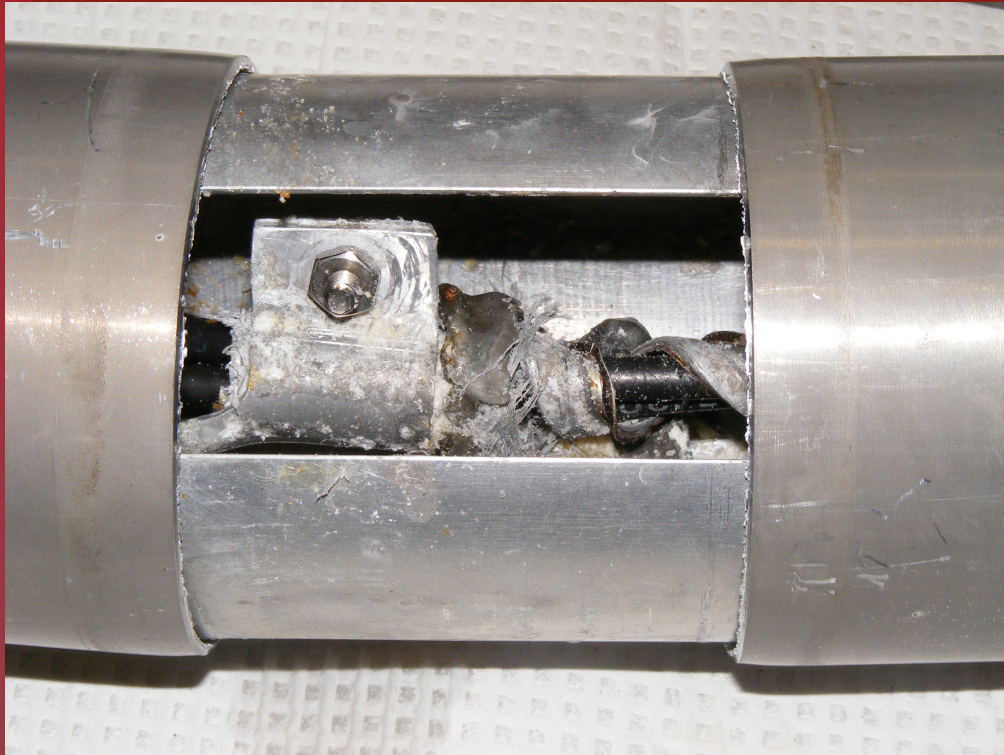
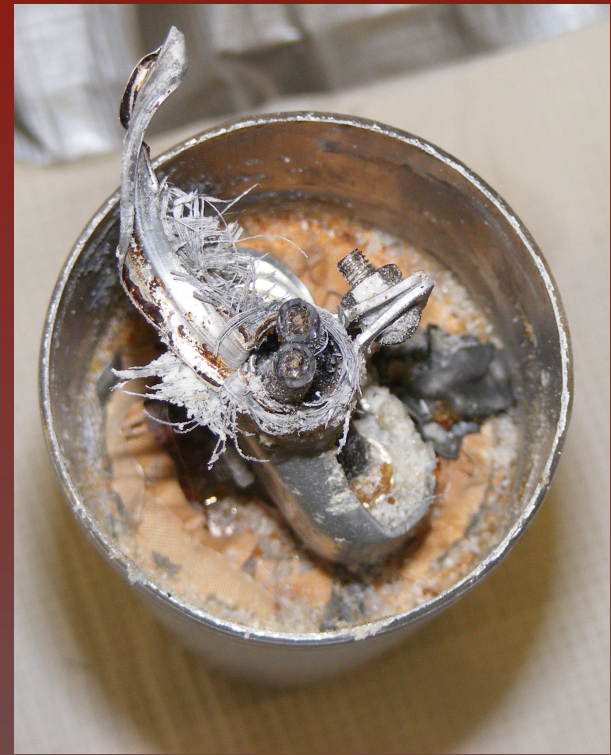
- A power supply was put in line with a DVM to measure current.
- With changing voltage in the HP supply, we observed a leakage current in the DVM, indicating a resistance between the +/- wires of about 130 μA at 300 V.
- Possibility of a bad MHV wire (or the connector, or the insulator inside the detector cap)

- Pulled the failed fission chamber out of the core and cut the housing open using a dye blade pipe cutter.

- OSU Reactor donated a fission chamber.
- GA sent detector cabling and insulation materials.
- Local shop fabricated detector can and performed chamber closure welds.
- Detector came with poly insulator that was replaced with teflon insulator milled in house.
