OPAL Reflector Vessel & leak mitigation

RVE He Leak Test - Method

RVE He Leak Test - Results

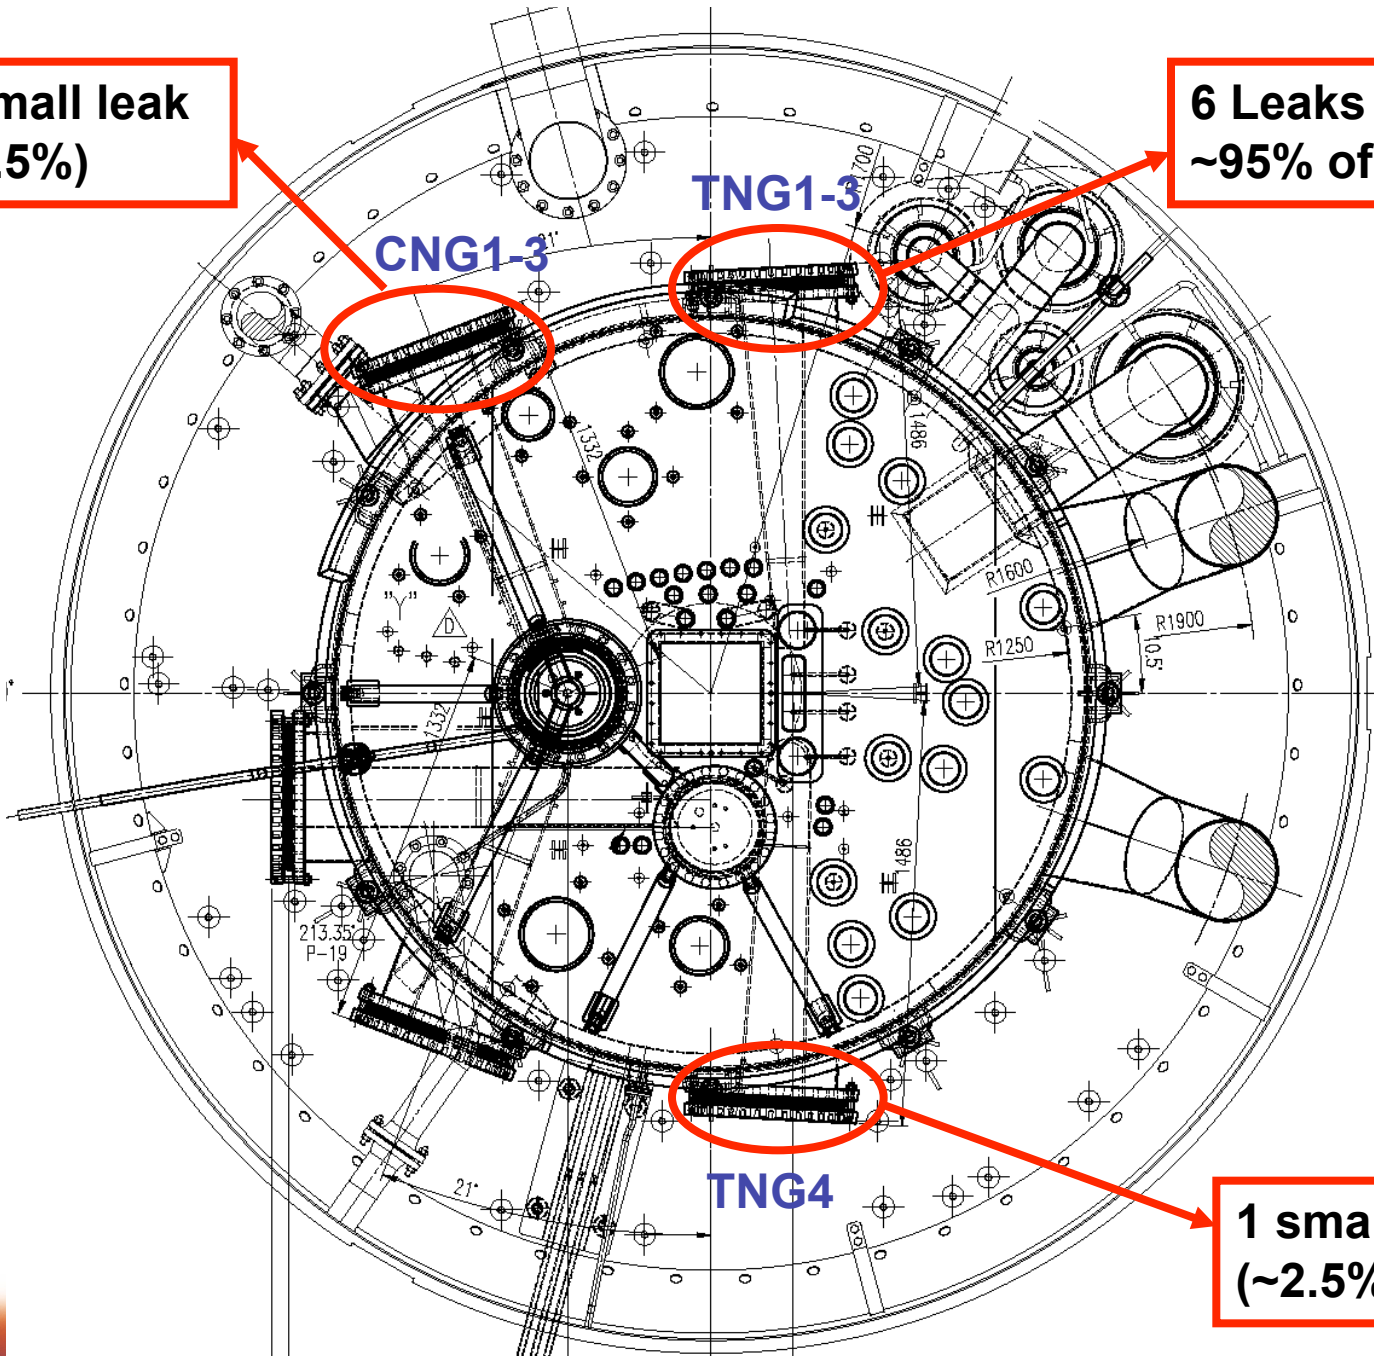
- First helium bubbles were observed 3 hours into the test from the TNG1-3 flange
- Smaller helium bubbles were observed on day 4 from CNG1-3 and TNG4
- No other leakages observed
- Collection of bubbles from the TNG1-3 leaks showed a leak rate consistent with the isotopic purity degradation

**1 small leak
(~2.5%)**

**6 Leaks comprising
~95% of leakage**

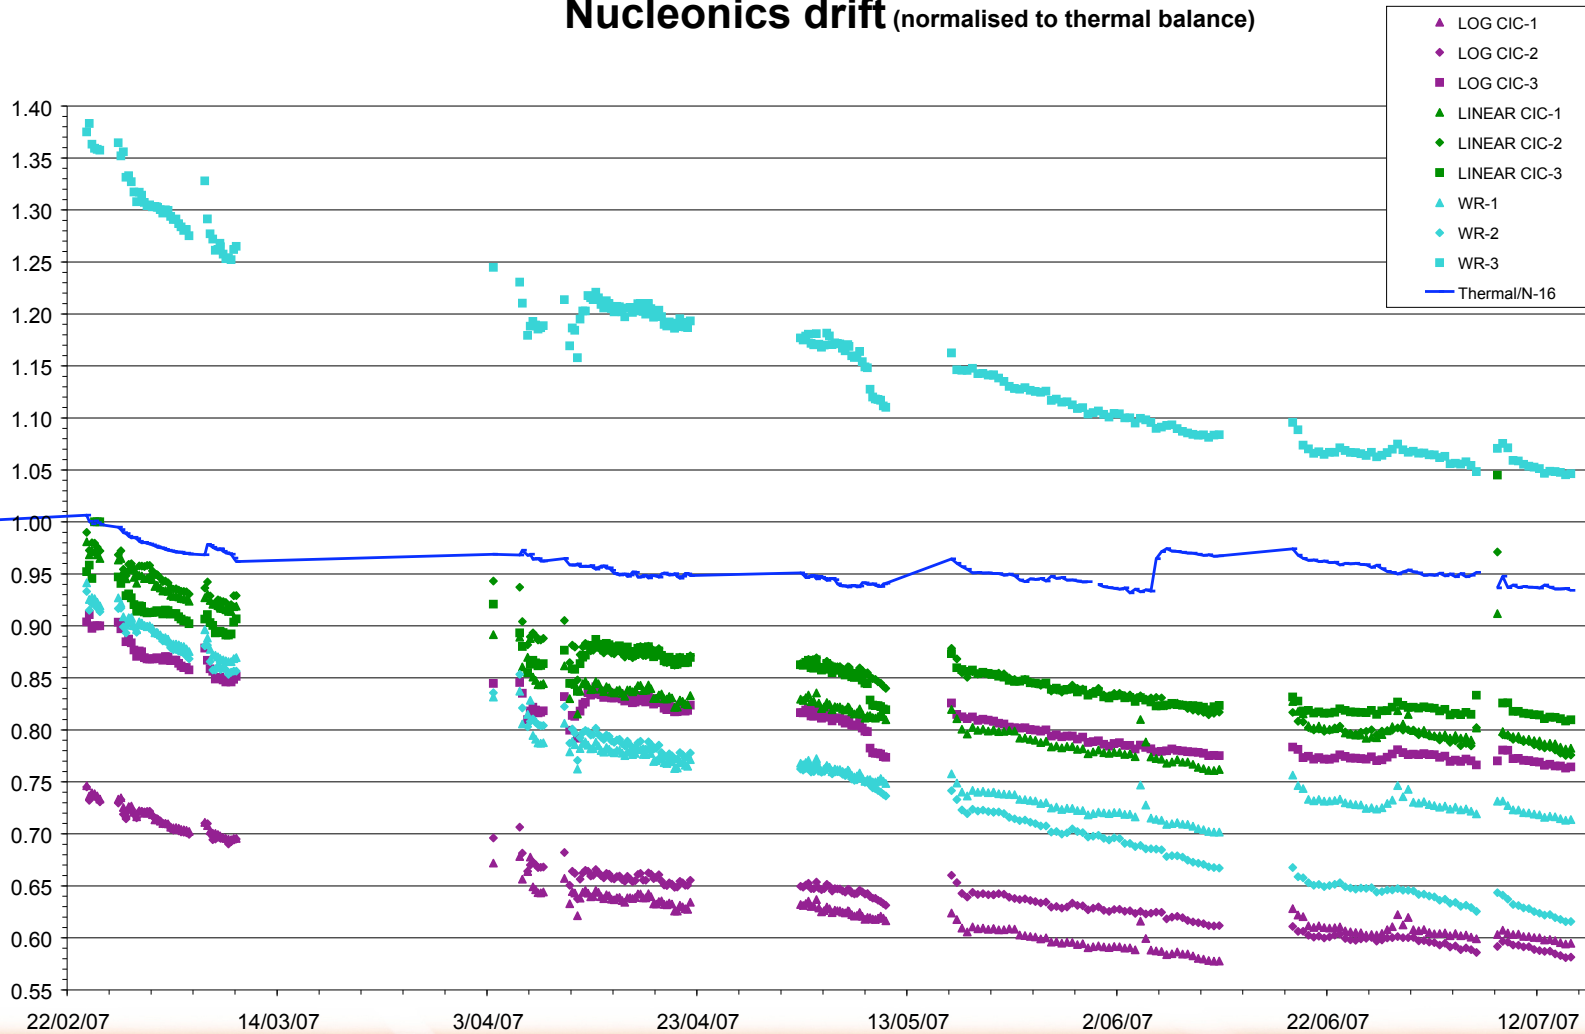
Nucleonic channels data - 2007

Nucleonics drift (normalised to thermal balance)

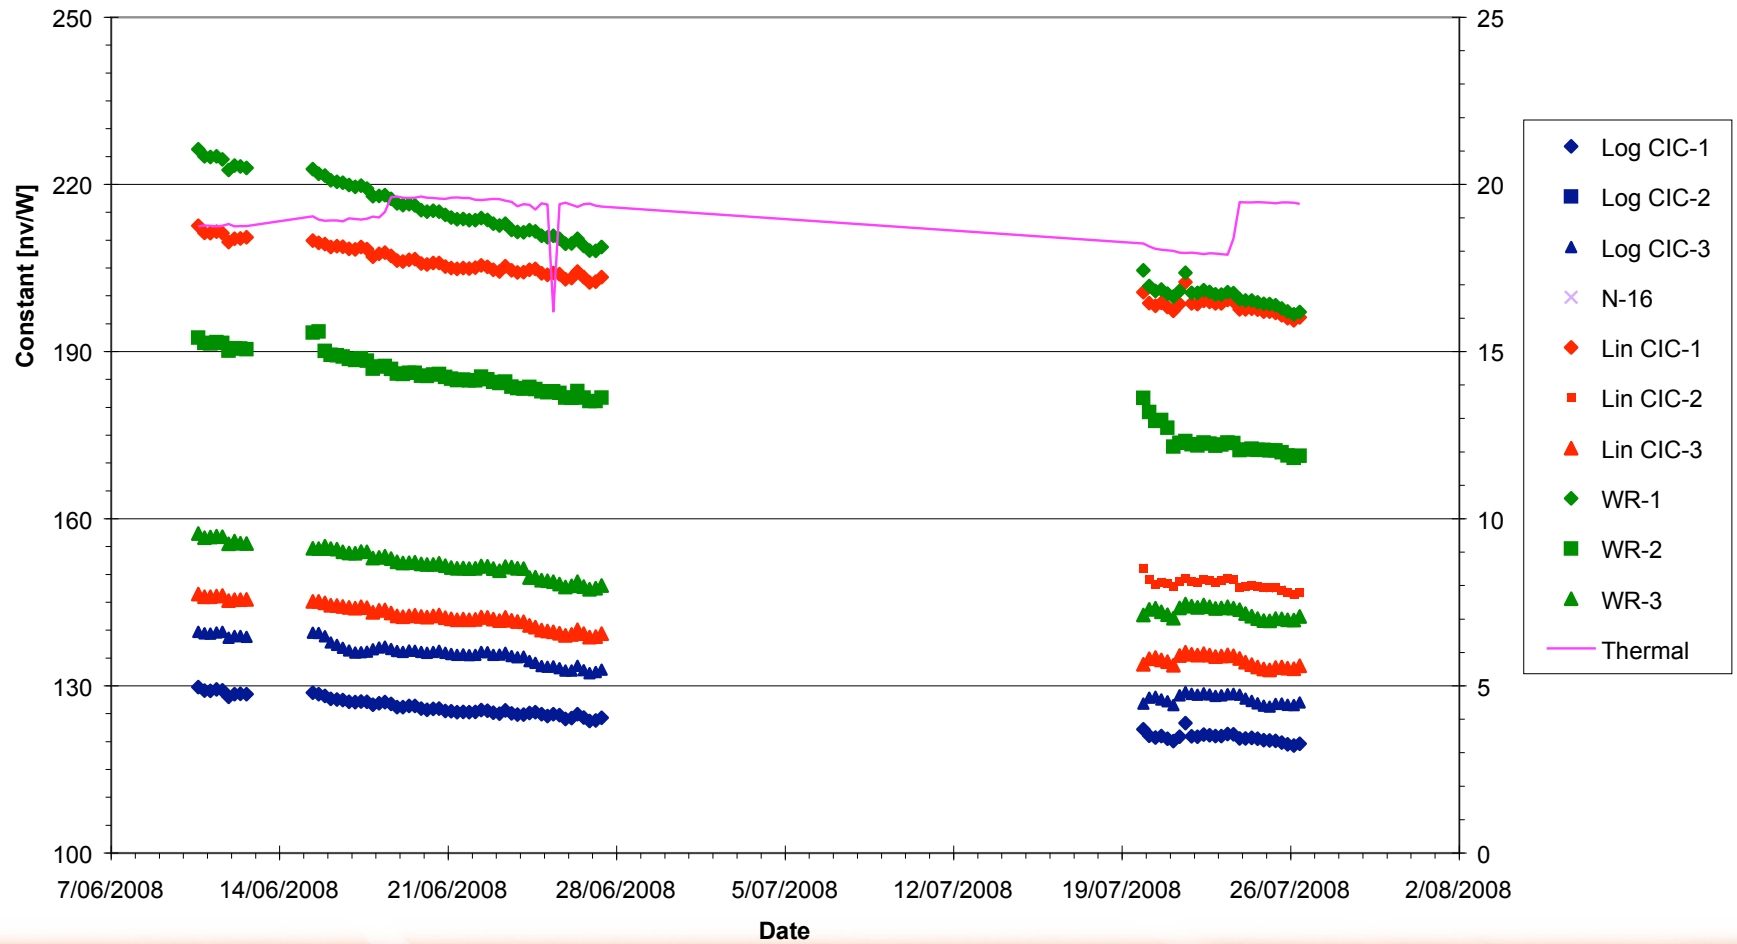
Nucleonic channels data - 2008

Nucleonics constants

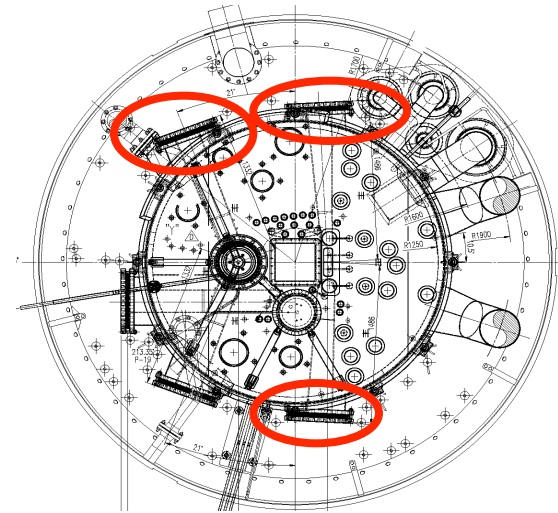
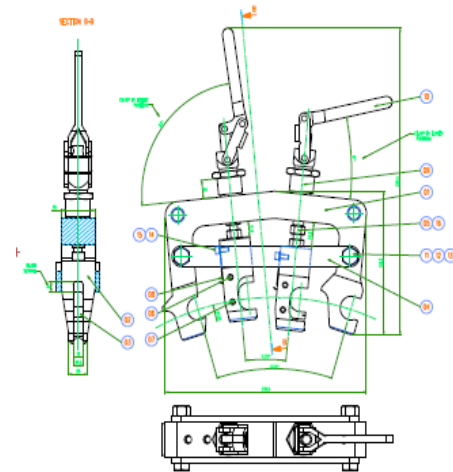
Reflector Vessel Trial Repair

- Remove fuel
- Lower Reactor Pool water
- Drain RVE
- Over-pressurise – He bubbles
- Apply clamps – graphite pads
- Bubbles halted on major leak sites
- Return to service
- Measured D2O purity

Application of Clamps
