THE UNIVERSITY OF UTAH

UUTR Tank Repair Efforts

Presented by
Andrew Allison
UUTR Reactor
Supervisor

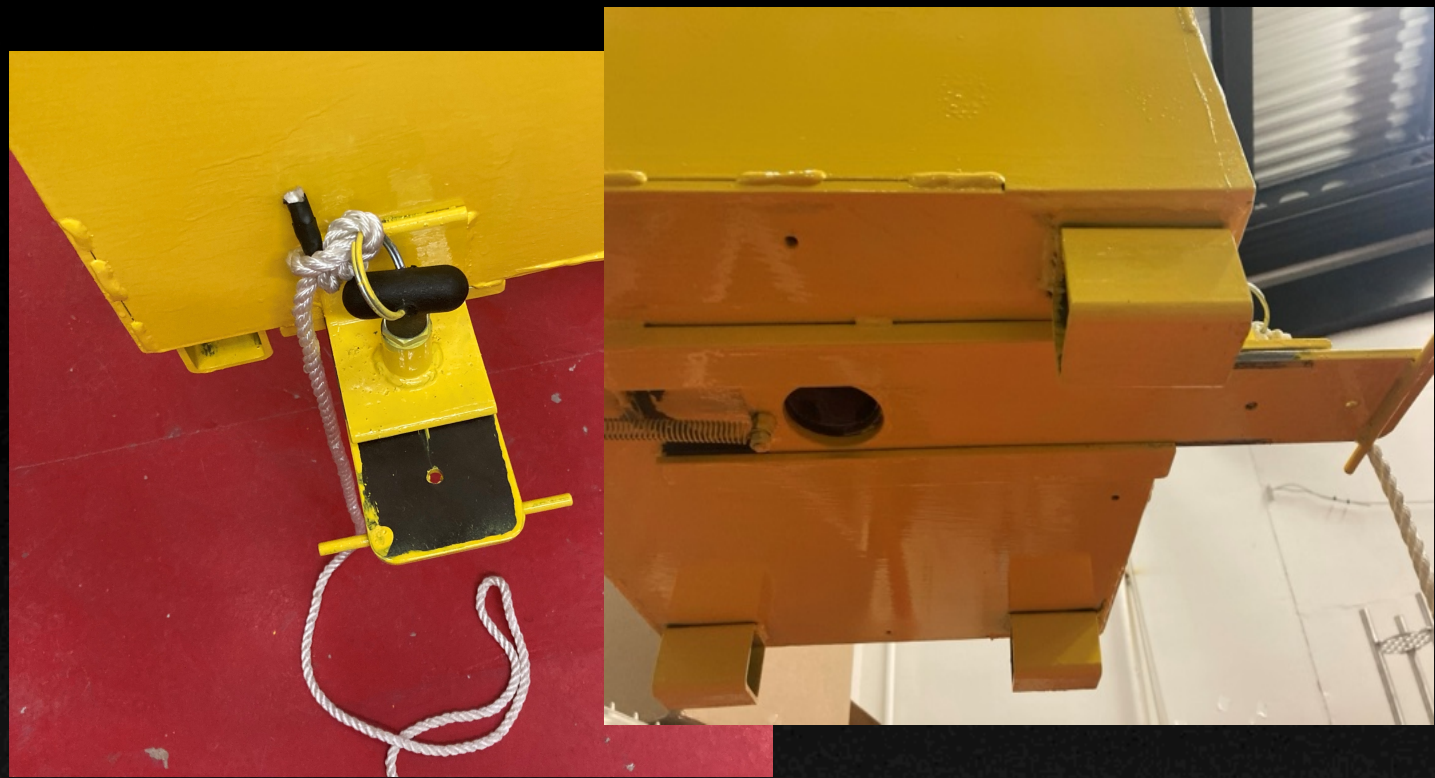
1. Trap door spring shut by pulling pin up allowed for elements to be secured in cask in partially drained tank

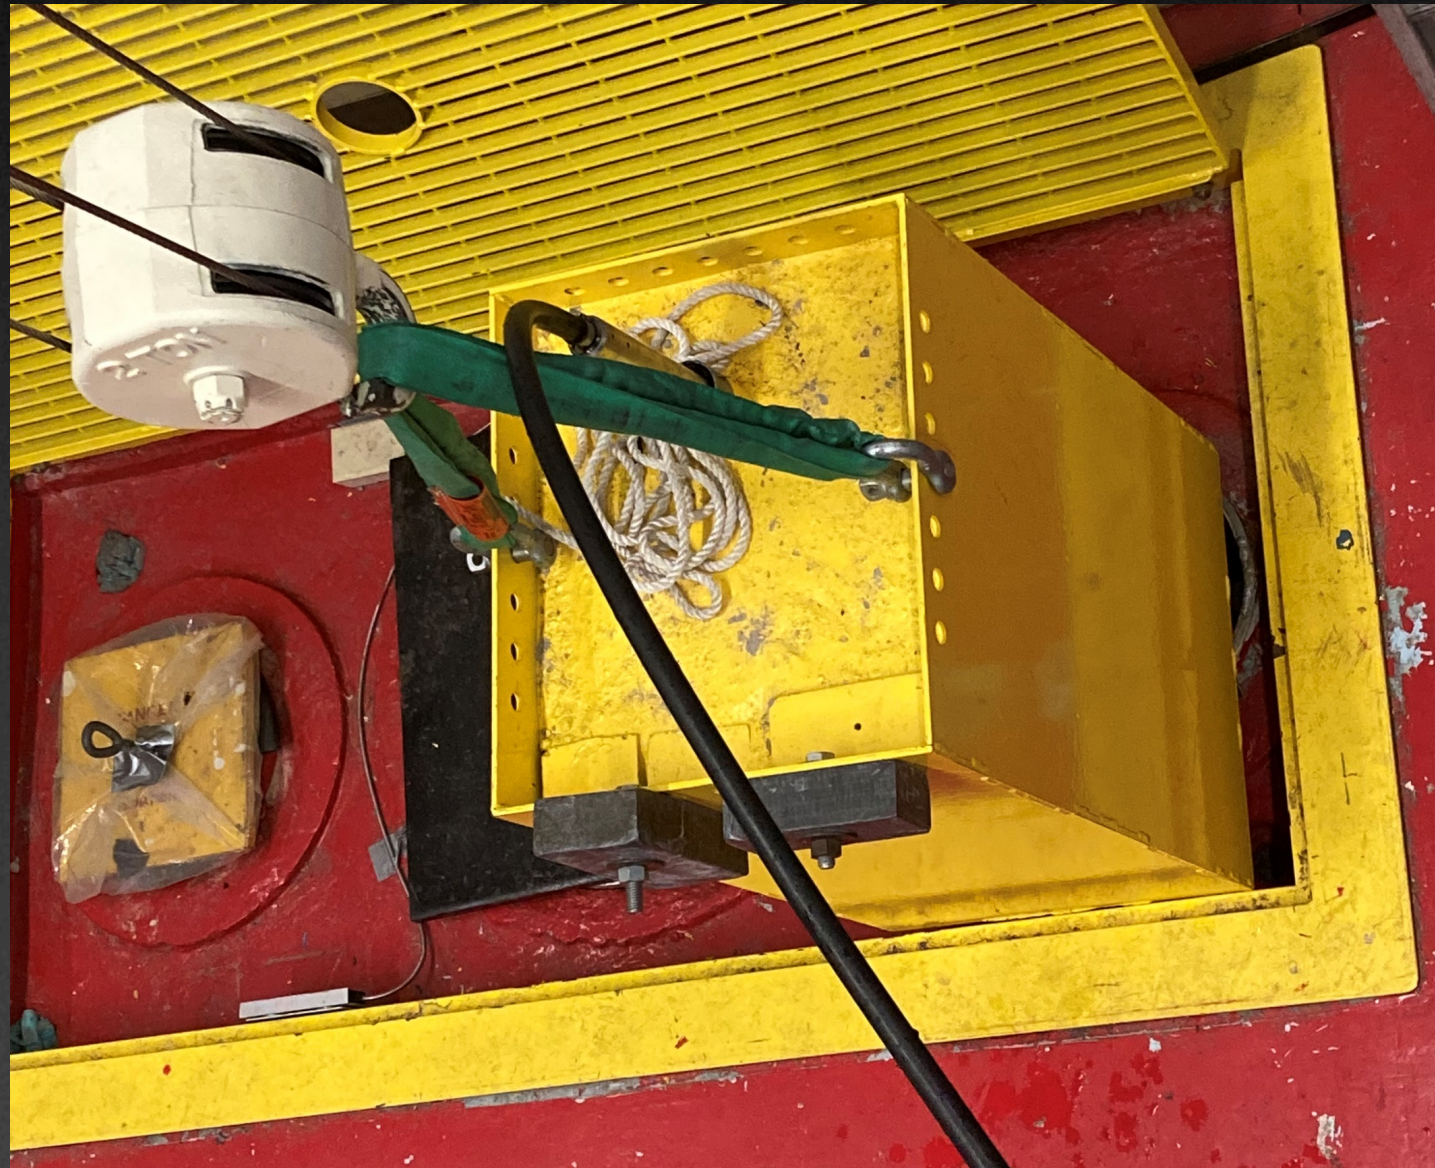
2. >3in of Lead

Shielding: fuel transfers no longer provided a detectable dose to public spaces.

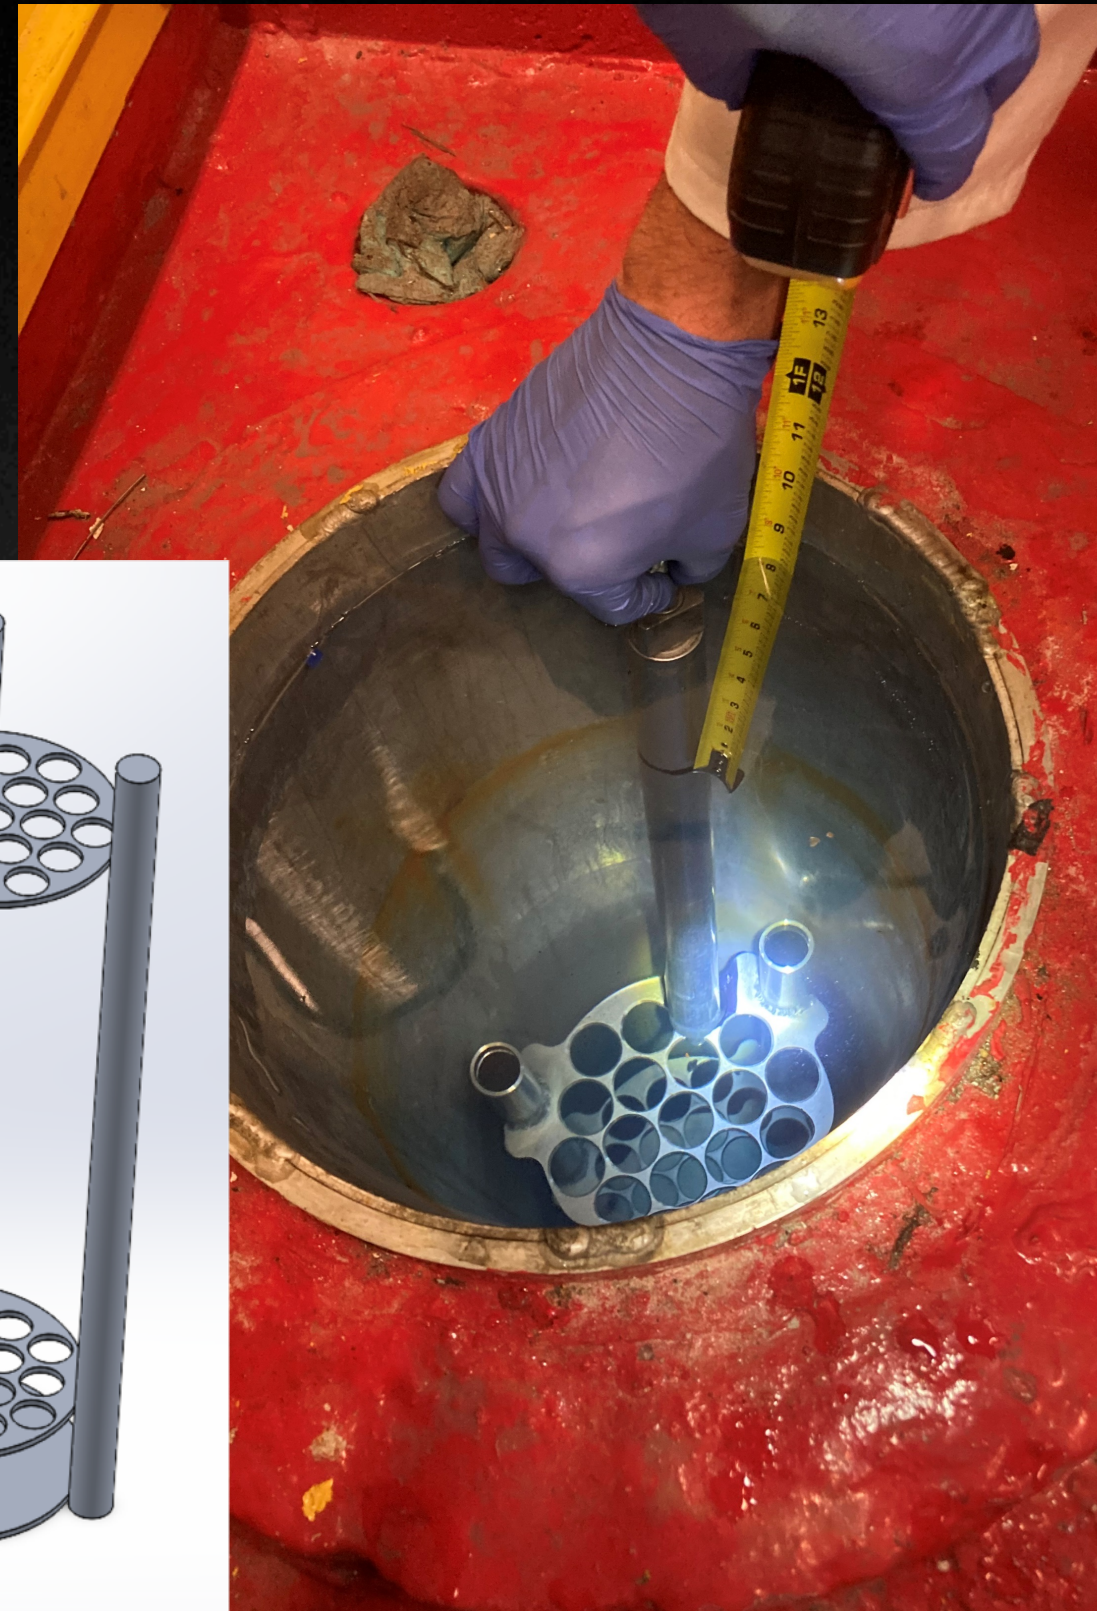
Storage of Fuel Elements in Pits

Most radioactive elements
stored in bottom assemblies
Least radioactive elements
stored in top assembly

Fuel Pit assembly design
prevents fuel elements
falling in between the pit
wall and assembly rack.

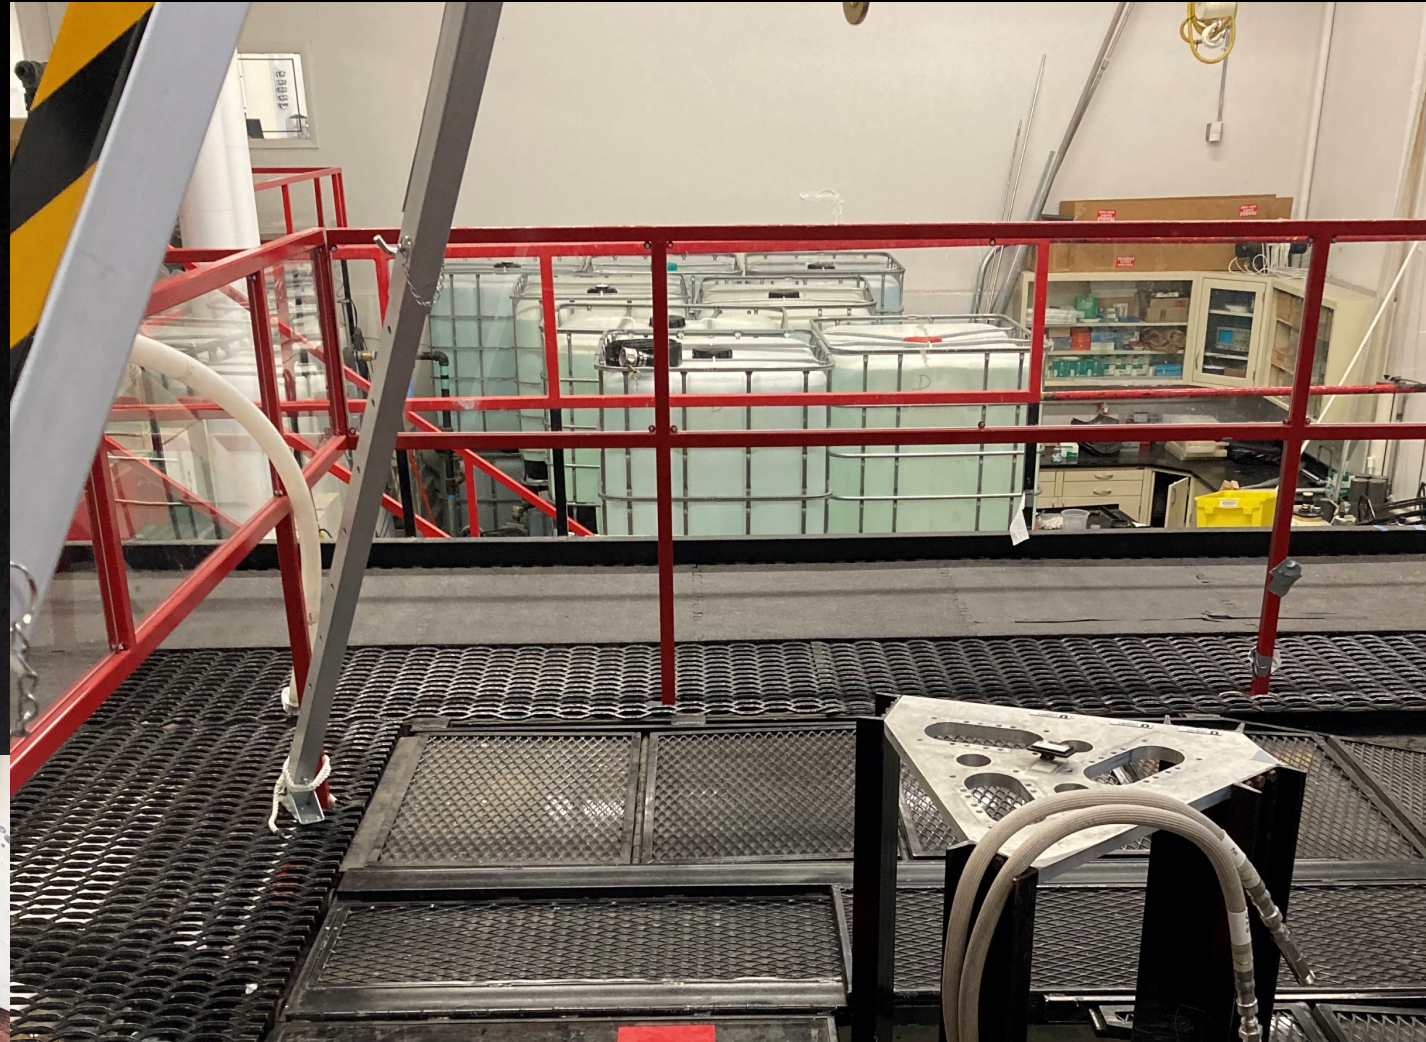
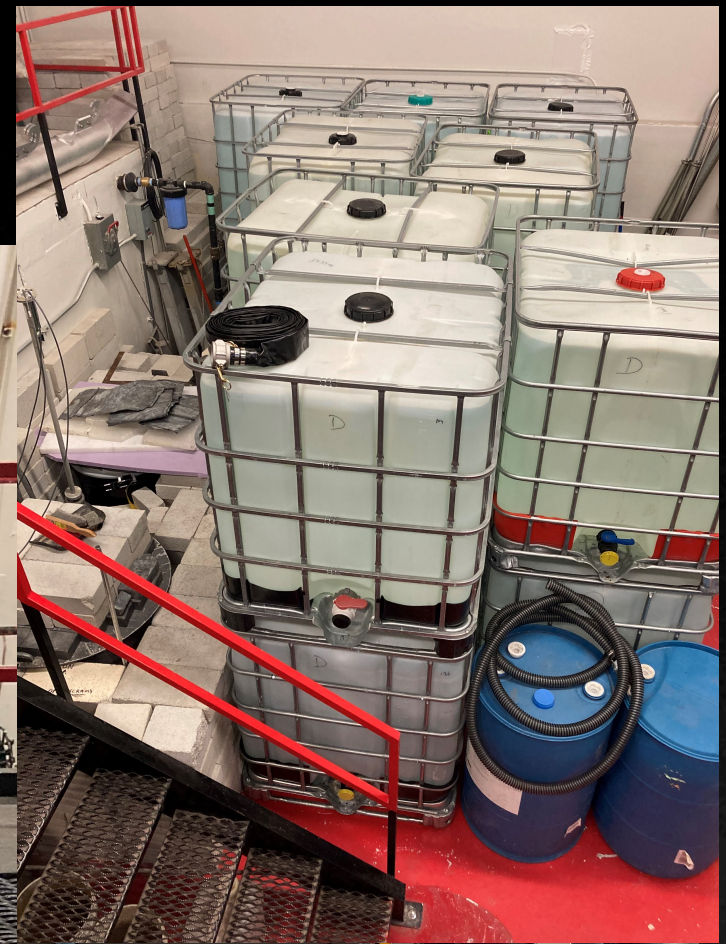
Emptying the Reactor

UUTR implemented confined space protocols and fall protection for workers entering the reactor tank

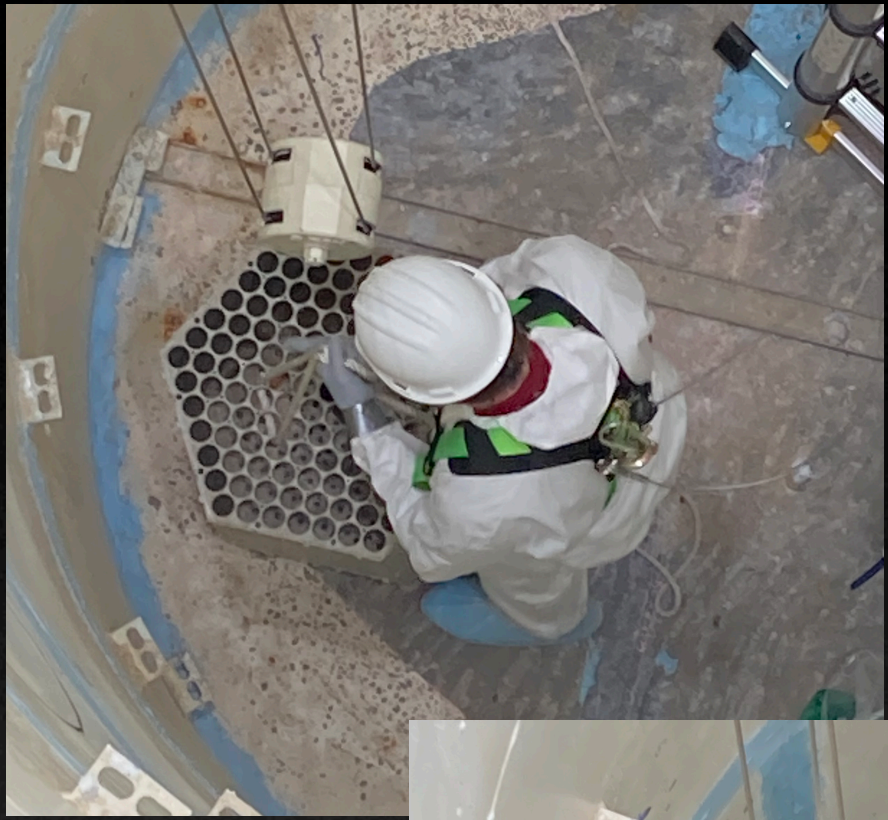
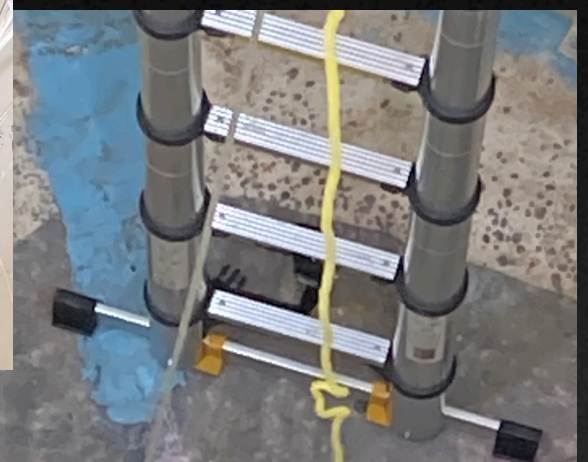
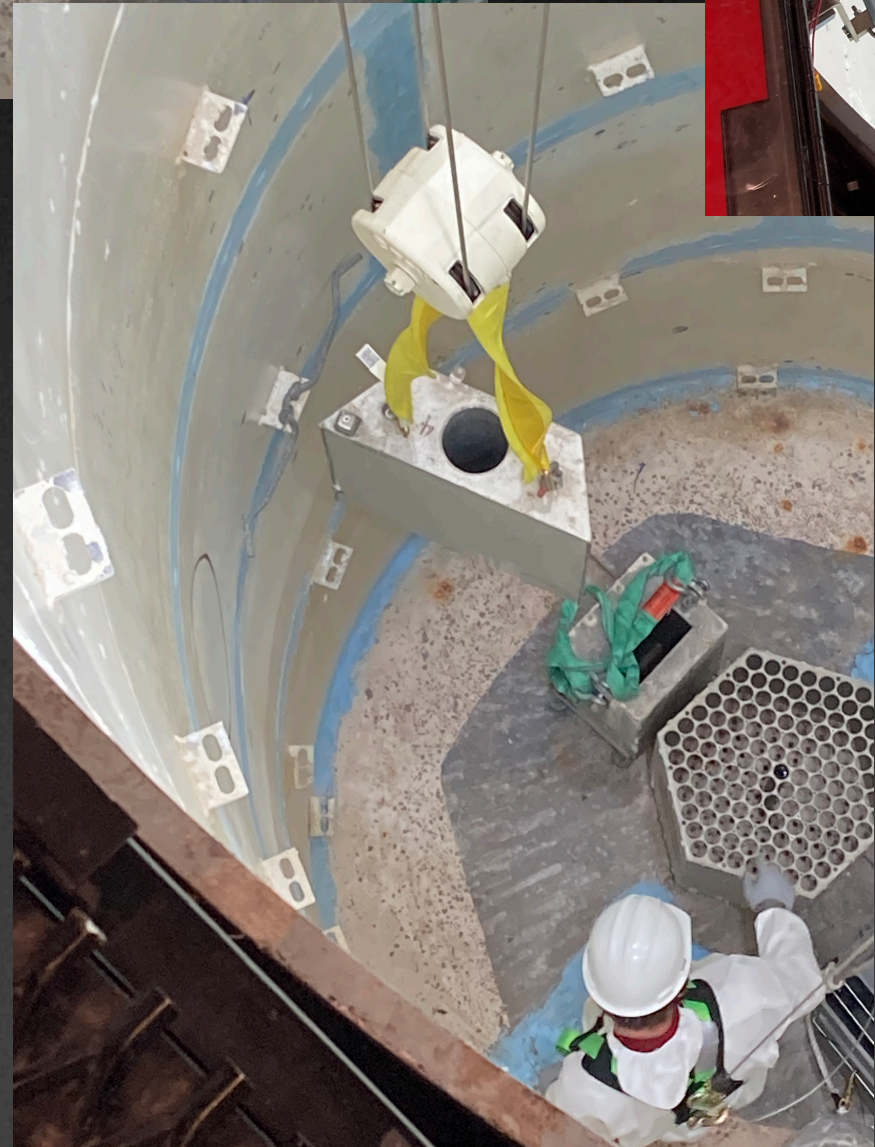
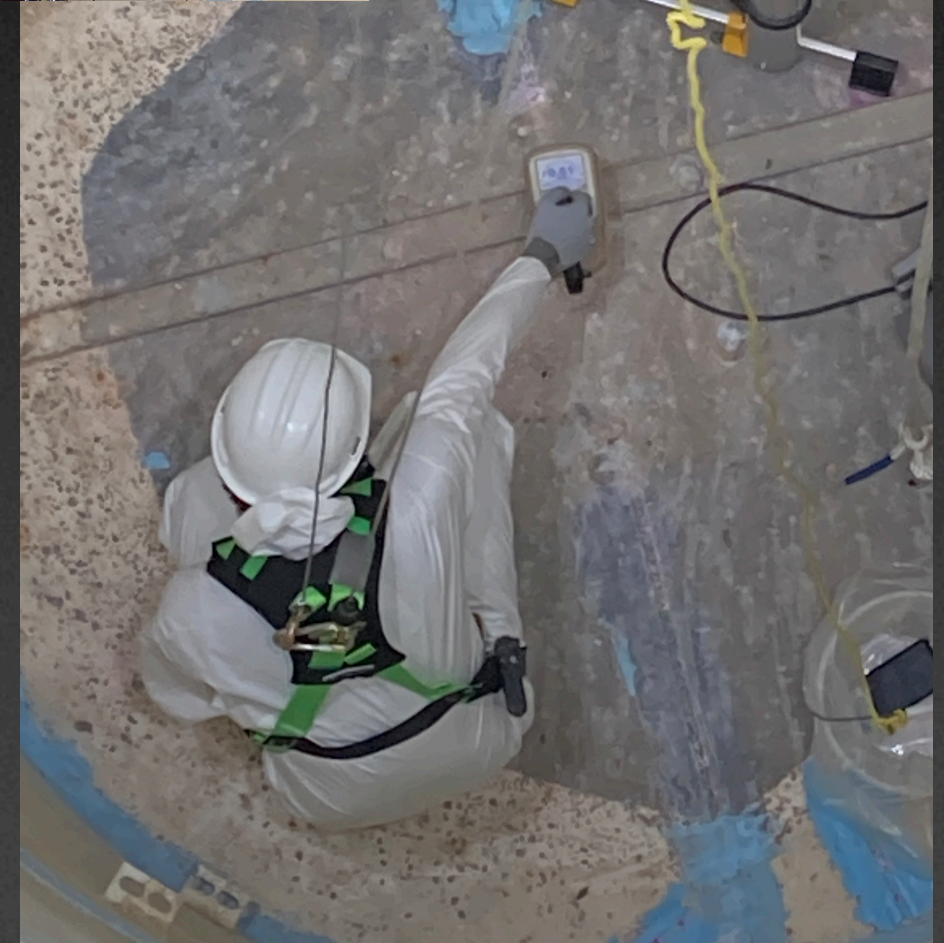
Center of core plate: 50mR/hr contact

Control rod bolts: 20mR/hr contact

Tank center bottom: 0.8mR/hr contact

Fuel element racks: 0.02mR/hr contact

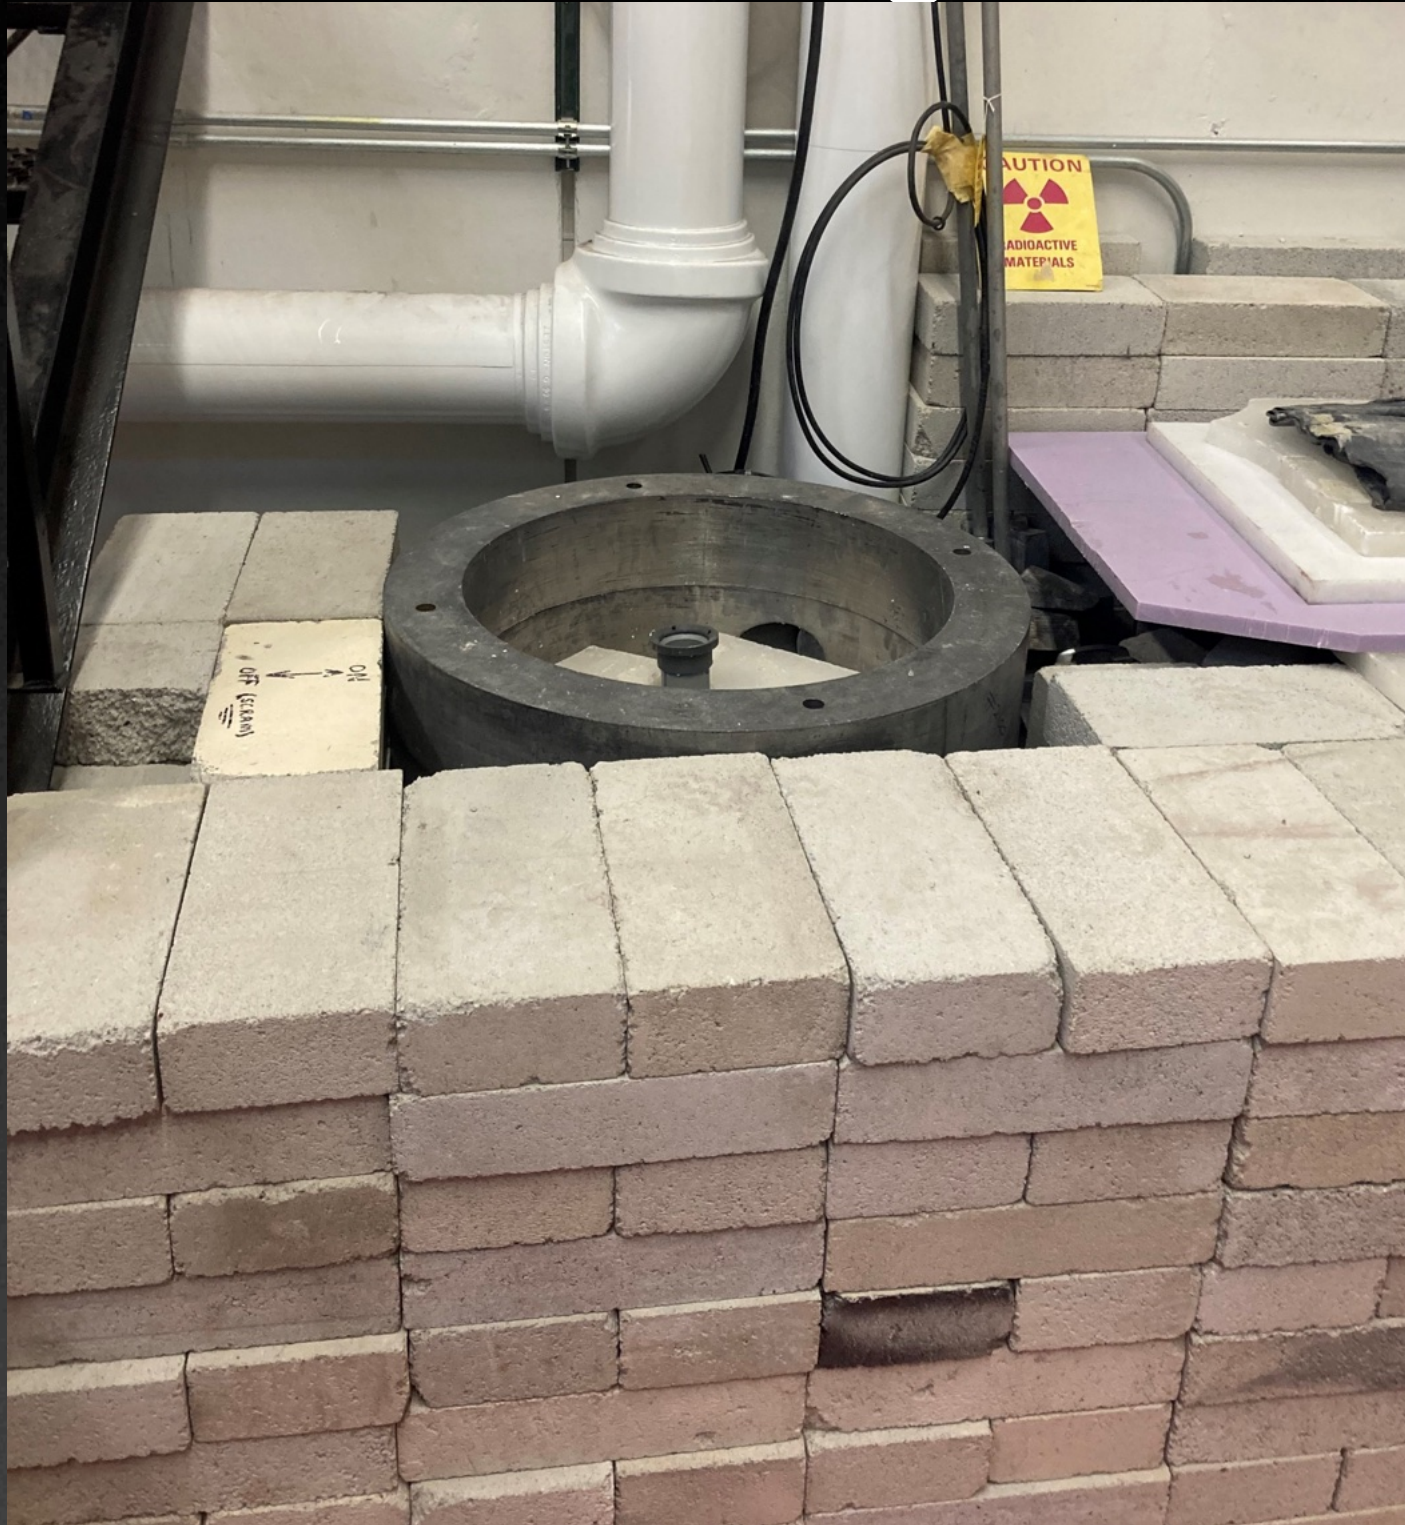
PuBe Bunker for long-term storage
