Aluminum Fuel Cladding Condition at the US Geological Survey TRIGA Reactor

US Geological Survey TRIGA Reactor (GSTR)

2023 Fuel Inspection

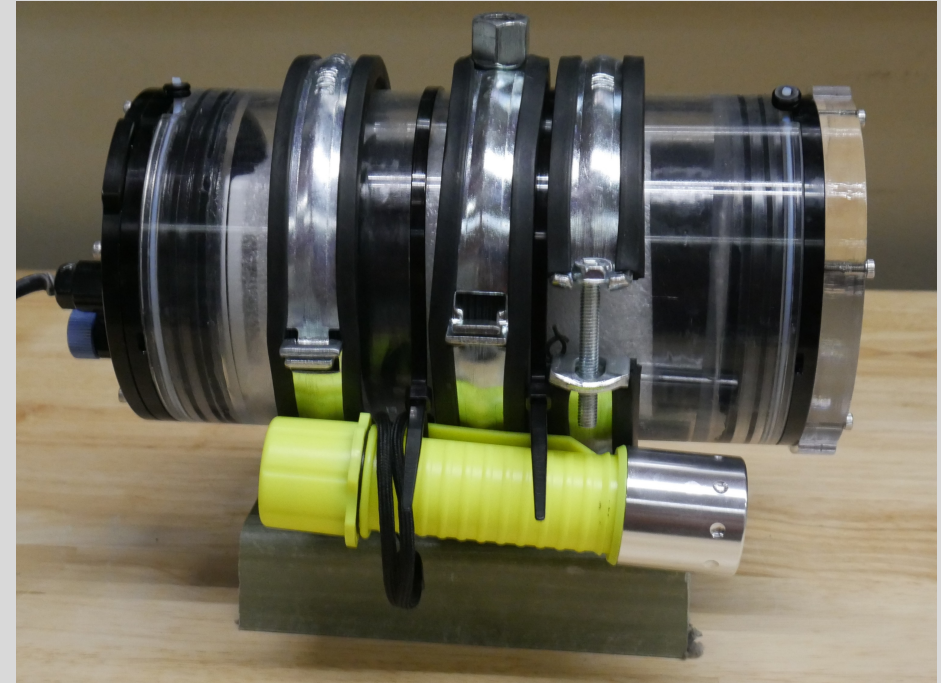
Underwater Camera System

- 4K video camera in underwater robotics enclosure
 - ~\$3000 in parts
- Diving flashlight
- Ethernet communication powered via PoE
- Remotely operated optical/digital zoom
- Fantastic video quality

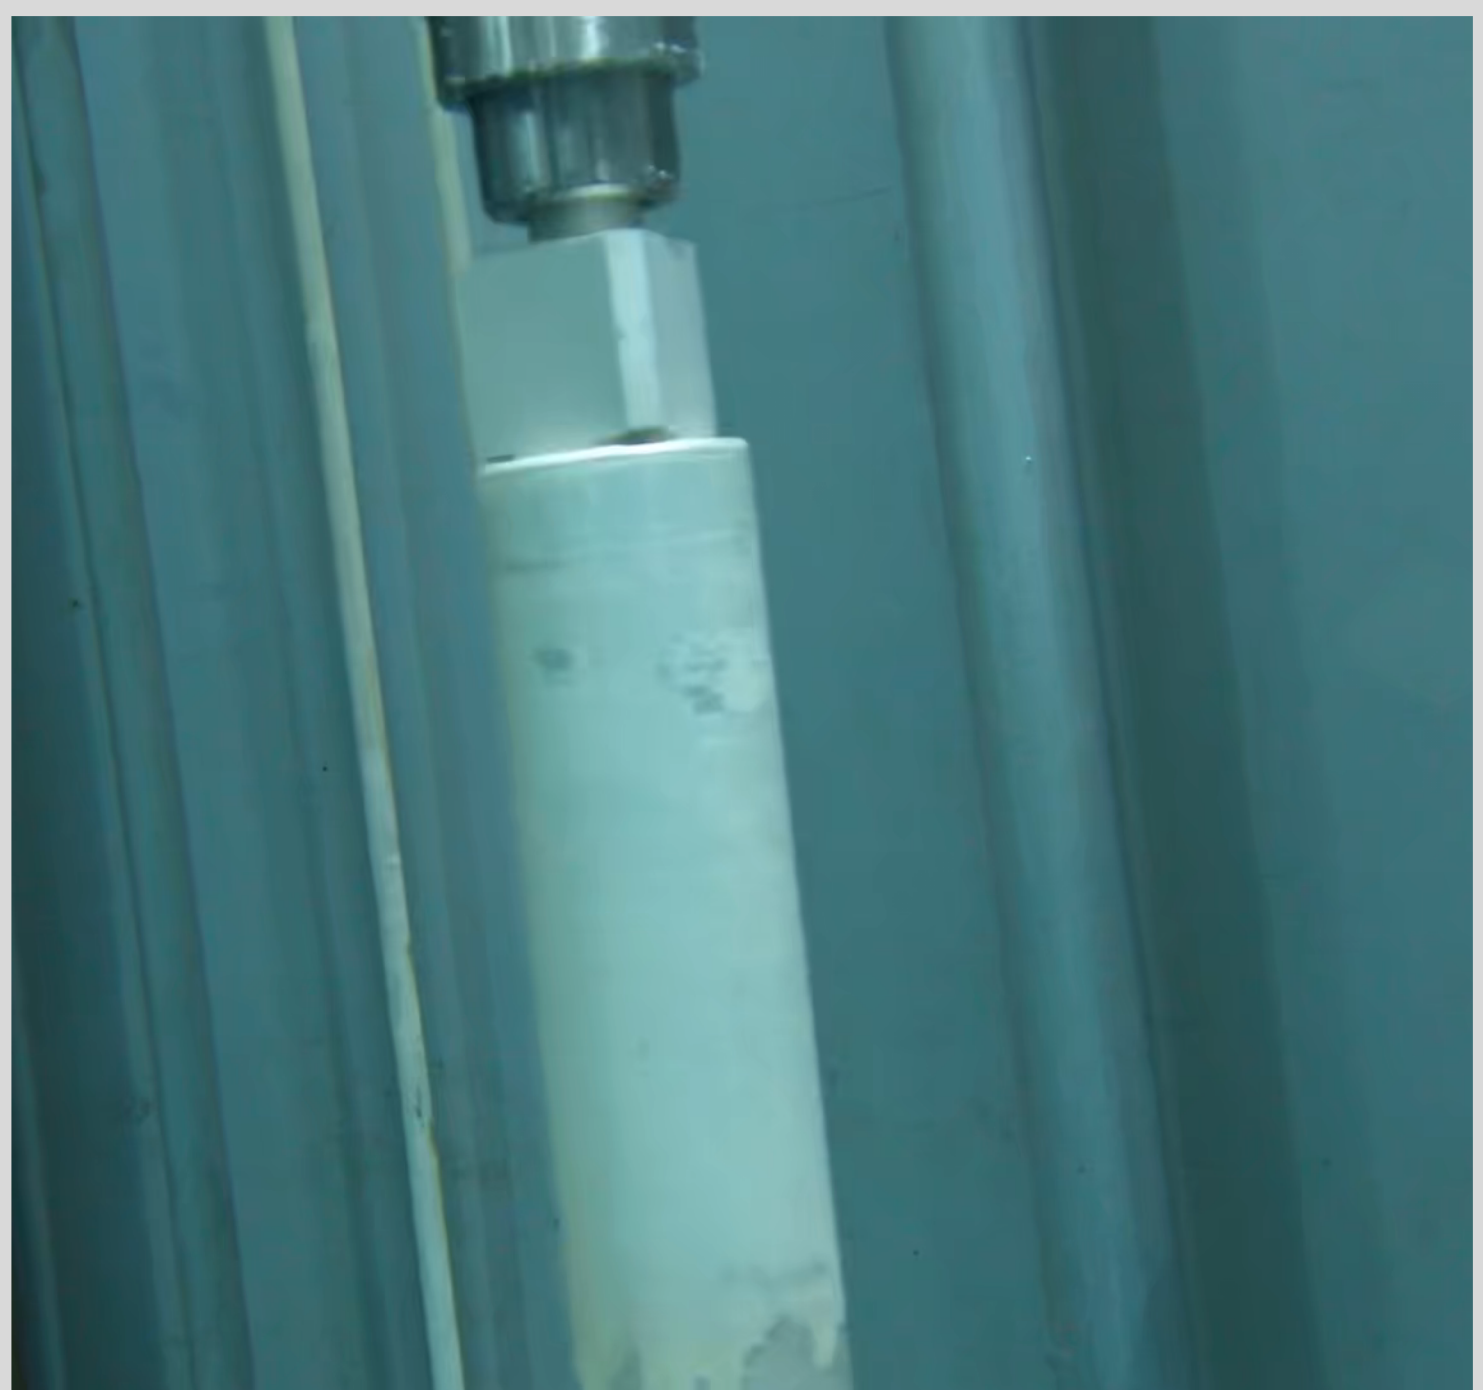
2023 Fuel Inspection Results

- Top 1/3 of element looks rather nondescript
- “Flaky” transition zone to a darker layer near graphite/fuel interface
- Shadows seem to indicate that the different zones have different depths

- Affects entire bulk of oxide layer of fuel section
- Temperature/heat?
 - GSTR: 1000 kW (pulsing!) vs VA: 20 kW (non-pulsing)
 - Significantly higher heat production despite restriction to F&G rings
 - Oxide spallation can occur if oxide layer builds up excessively under high temperature conditions
 - Growth/spallation cycles
- Not many other users of Al-clad TRIGA fuel that share our operational envelope

- Chemical?
 - 2014 - ~10 mL of bromine-containing compound leaked from sample container into reactor pool water
 - No pitting corrosion identified on Al-clad fuel
 - This effect is not seen on any other aluminum core or tank surfaces
 - Unlikely to be due *solely* from chemical attack
- Coupled chemical/temperature mechanism?
 - Chemical attack initiates oxide growth
 - Temperature/heat profile commences the spallation cycle

- Since:
 - The cladding on the Al-clad fuel has apparent material loss in the fuel section,
 - GSTR does not have the capability to quantify the thickness of cladding remaining, and
 - The root cause remains indeterminate:
- All Al-clad fuel has been removed from service
 - In accordance with Technical Specifications, and good operating sense
- All fuel in GSTR possession is being inspected with camera system to assess status
 - Still in progress

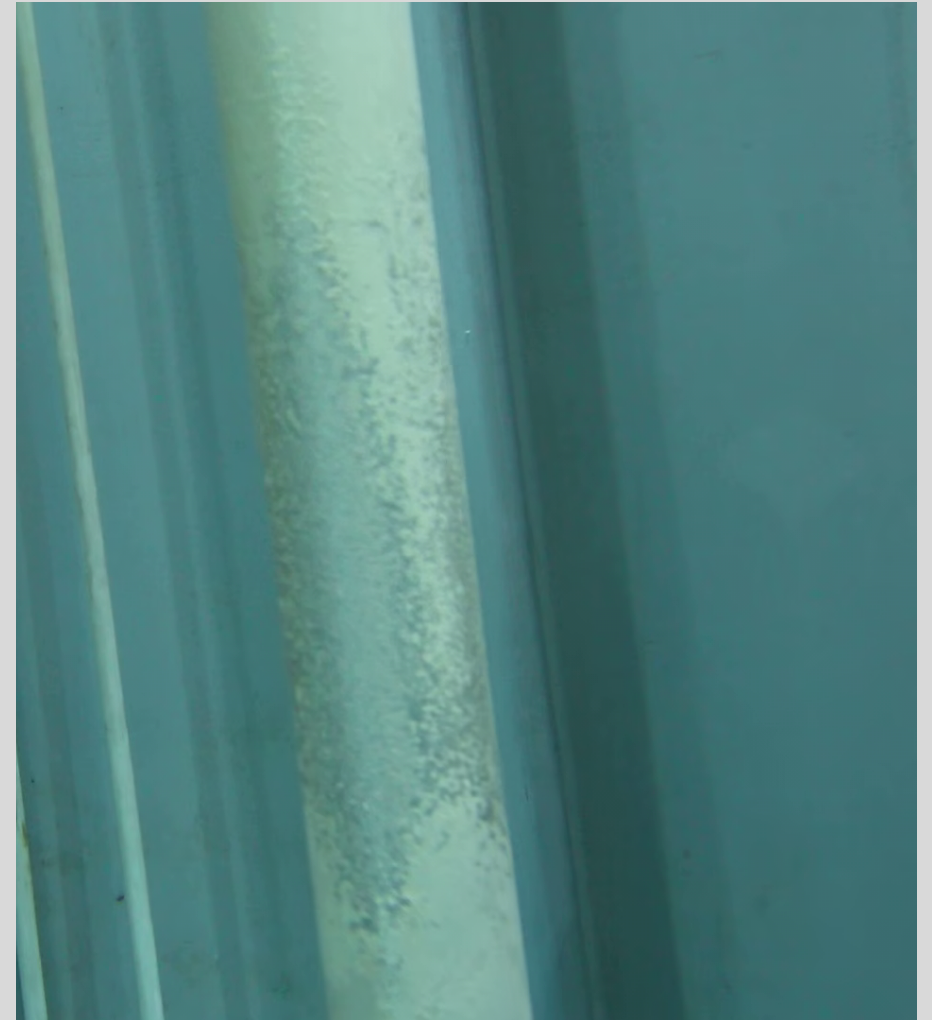
- Middle of element tends to have a “speckled” pattern to it
- Some of this pattern appears to have tiny little bumps or texture to it

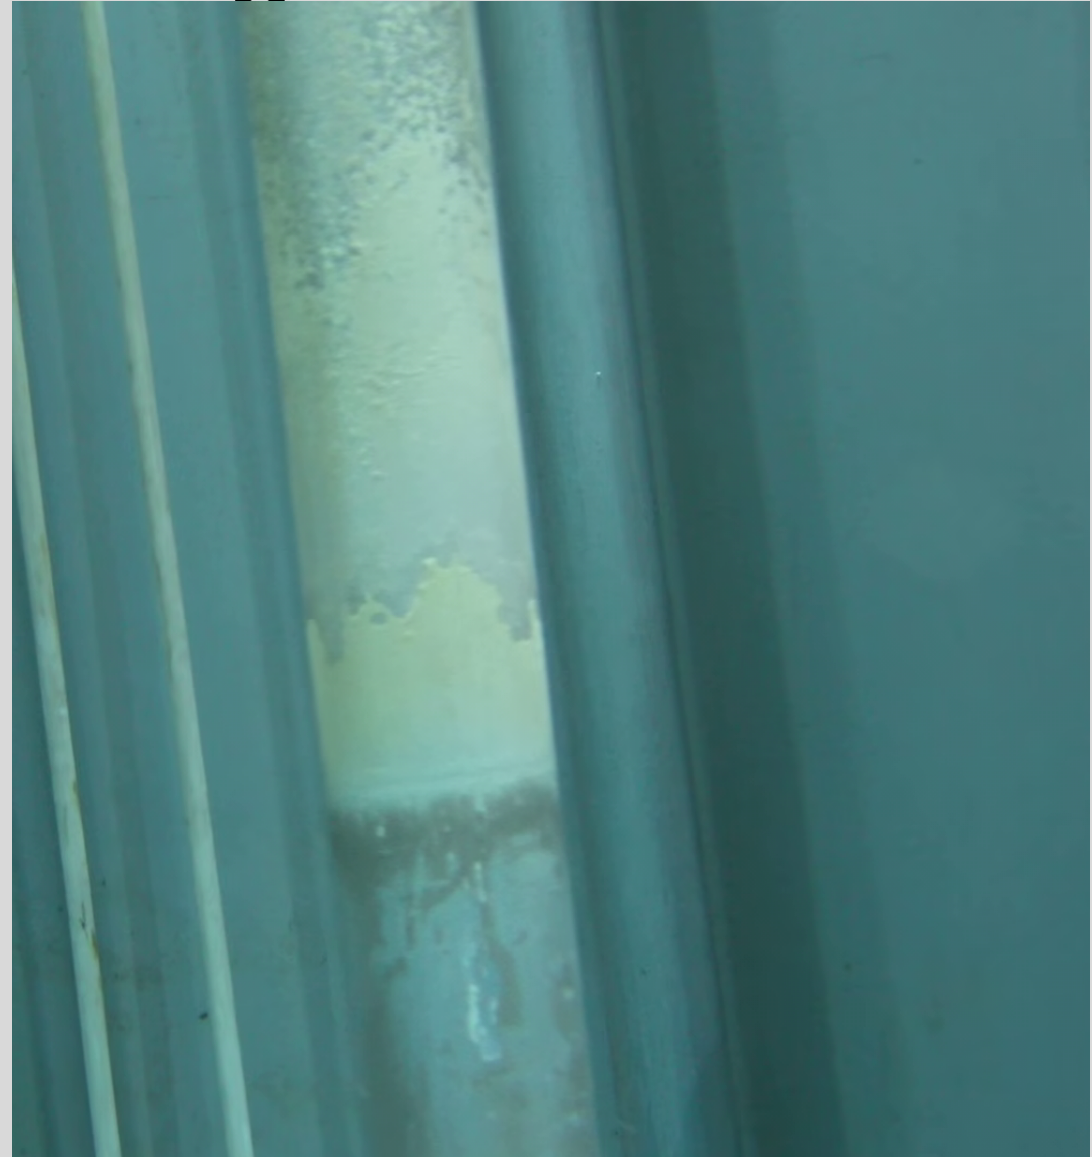
- Similar flaky layer near bottom graphite/fuel transition zone
- Lower graphite section much darker than upper section
