## Reasons for Reflector Replacement

# Timeline for Reflector Repair

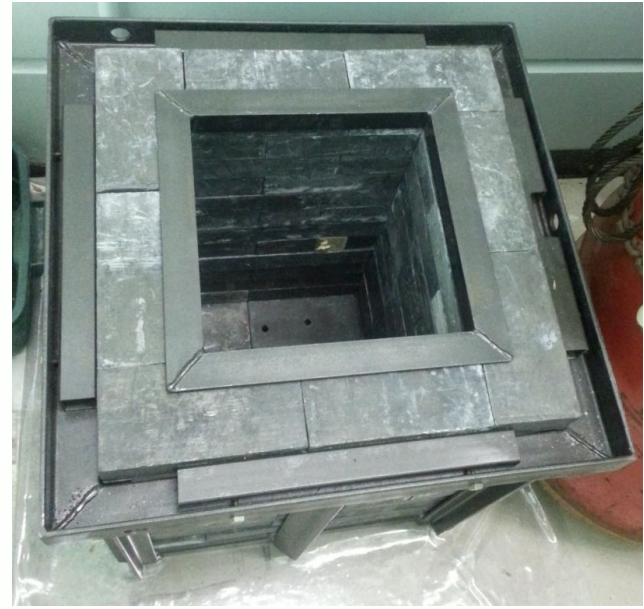
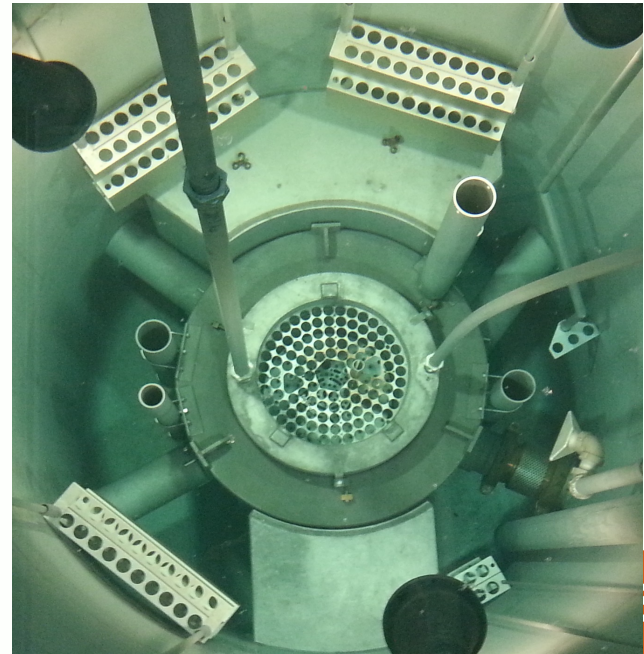
- July 1<sup>st</sup>, 2013
  - Beginning of outage, waiting for fuel cooldown
  - Fabrication of transfer basket for bellows/steel tank parts removal
  - Mounted a temporary camera on reactor top to record significant events
- August 5<sup>th</sup>-8<sup>th</sup>, 2013
  - Began transfer of fuel from primary tank to adjacent bulk-shield tank (BST)
  - Removed all in-core fuel, graphite and irradiation facilities
