# **A Brief History of the NRU Reactor Vessel Leak and Repair**

TRTR Conference

G.B. Wilkin

2010 September 19-24

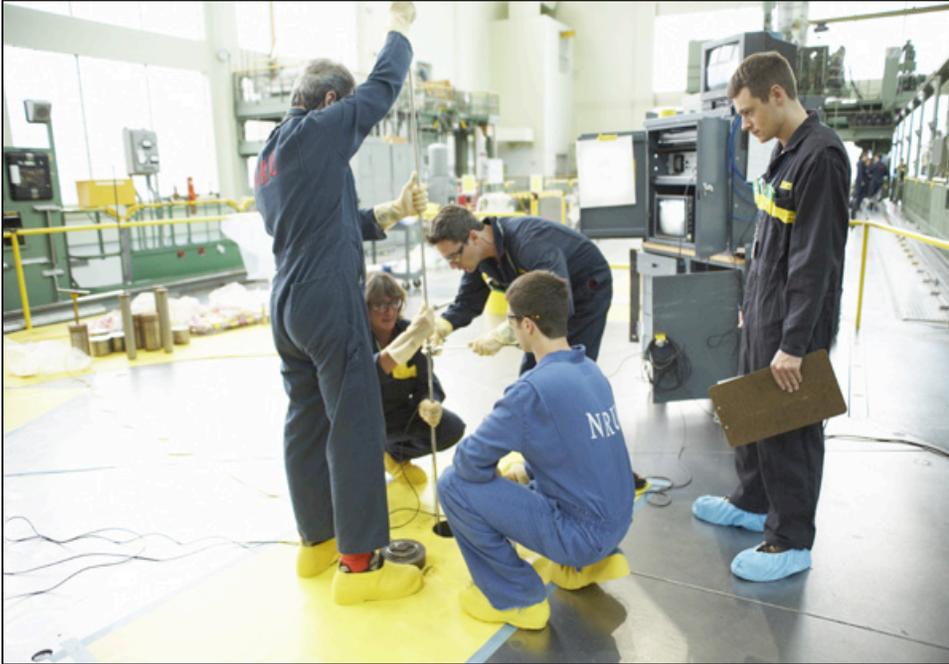
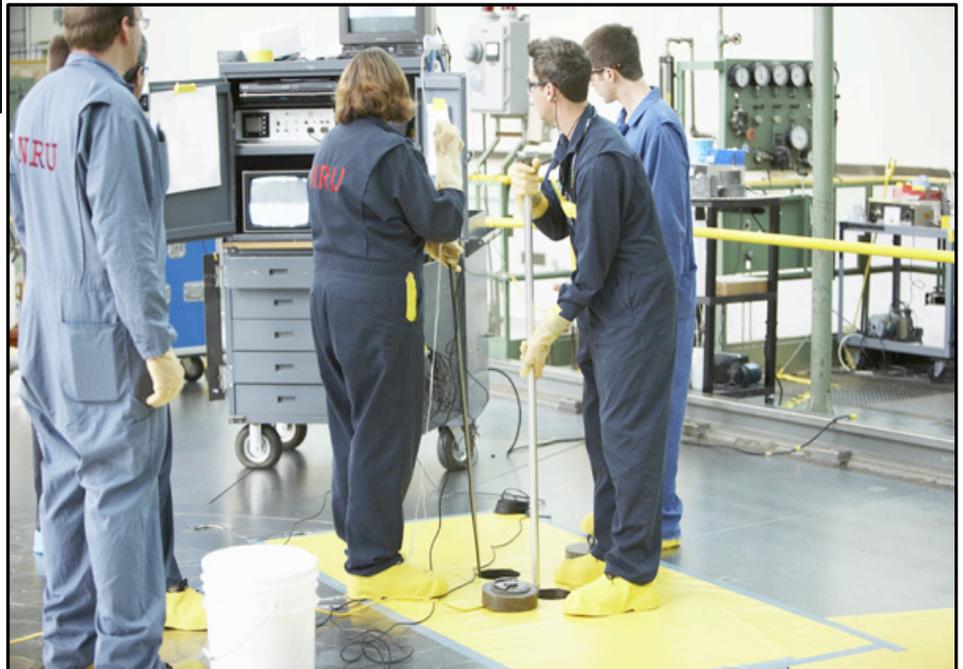
# Condition Assessment of Vessel

## Non-destructive examination:

- Remote video inspections
- Ultra-sound examination
- Eddy current probes
- Over two million data points
- Four phases

One of largest single NDE inspection campaigns ever carried out in the nuclear industry.

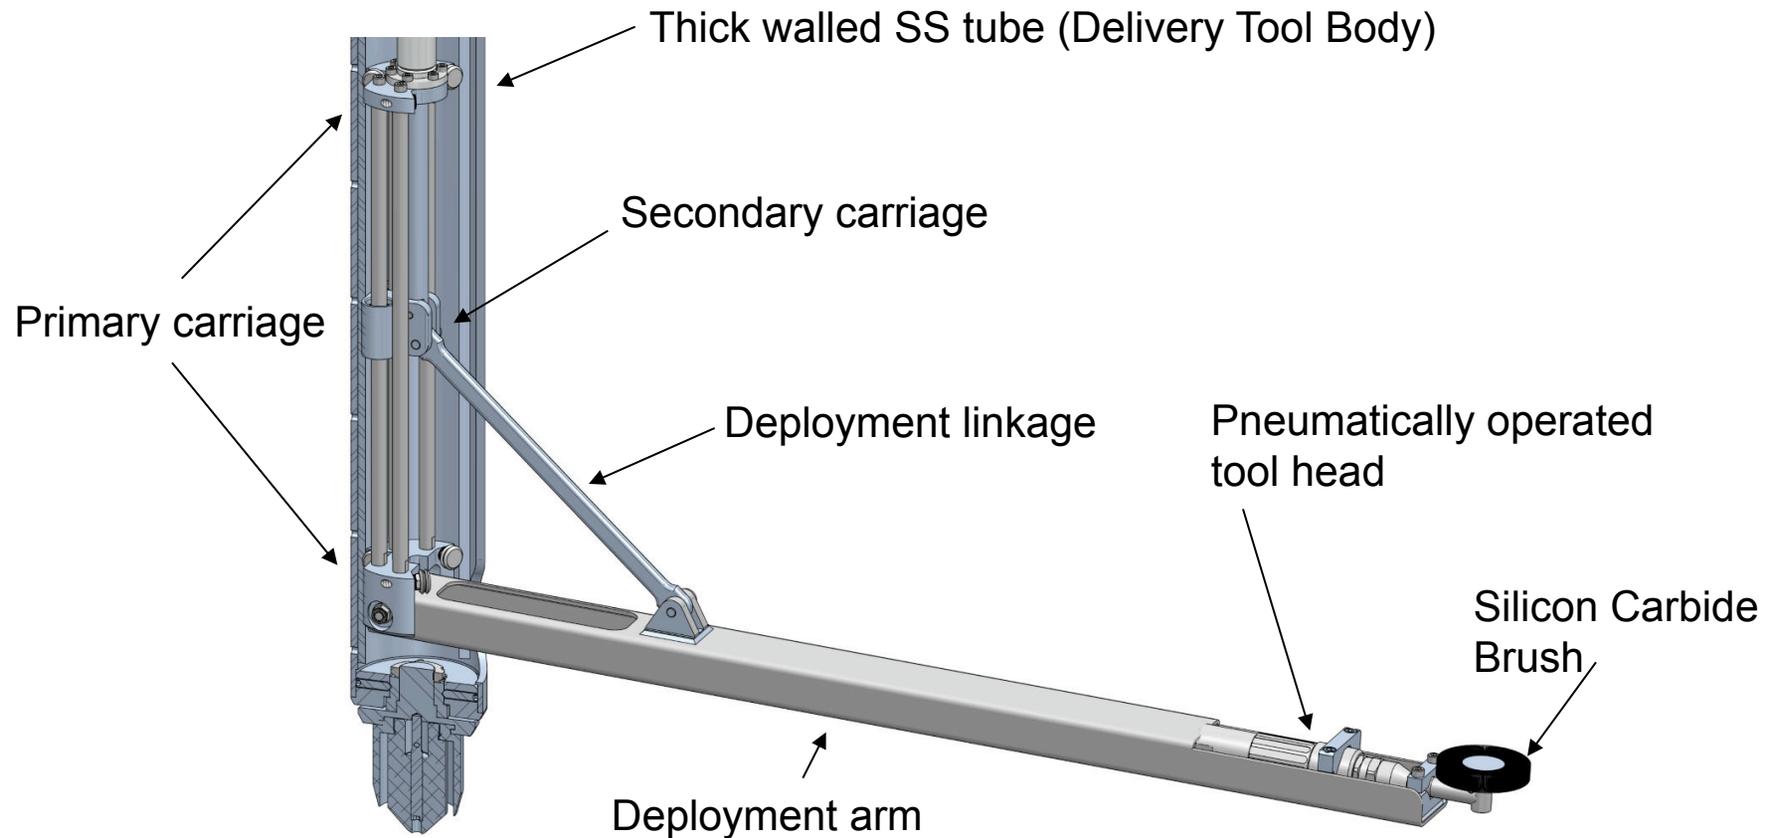
# Cleaning Tool Deployment Arm

- Arm has 965 mm horizontal reach

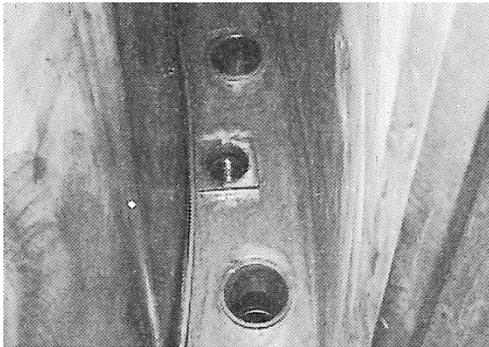
# Vessel Annulus – Preventing Corrosion

1 – as built

On going monitoring of condition of annulus will be integrated into annual maintenance outage of NRU

- clearing drains & reducing debris
- sealing water and air leaks
- higher CO<sub>2</sub> volume, improved distribution, better sampling system
