# MIT NUCLEAR REACTOR LABORATORY

## Re-starting from scratch: Waking up MITR II Nuclear Instrumentation

# MIT Research Reactor (MITR-II)

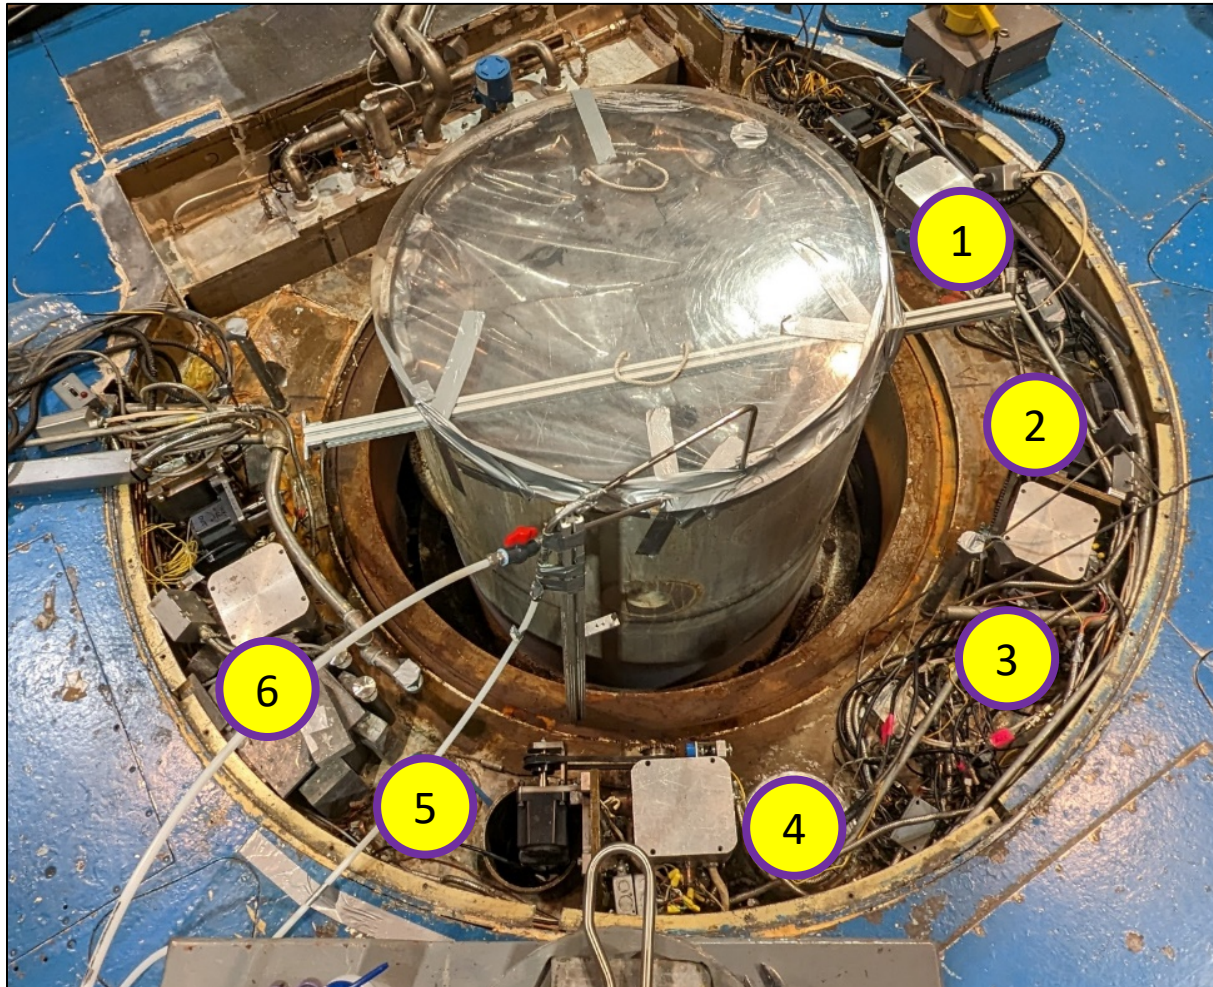
## *Instrumentation Vertical Ports*

# Disassembly Begins

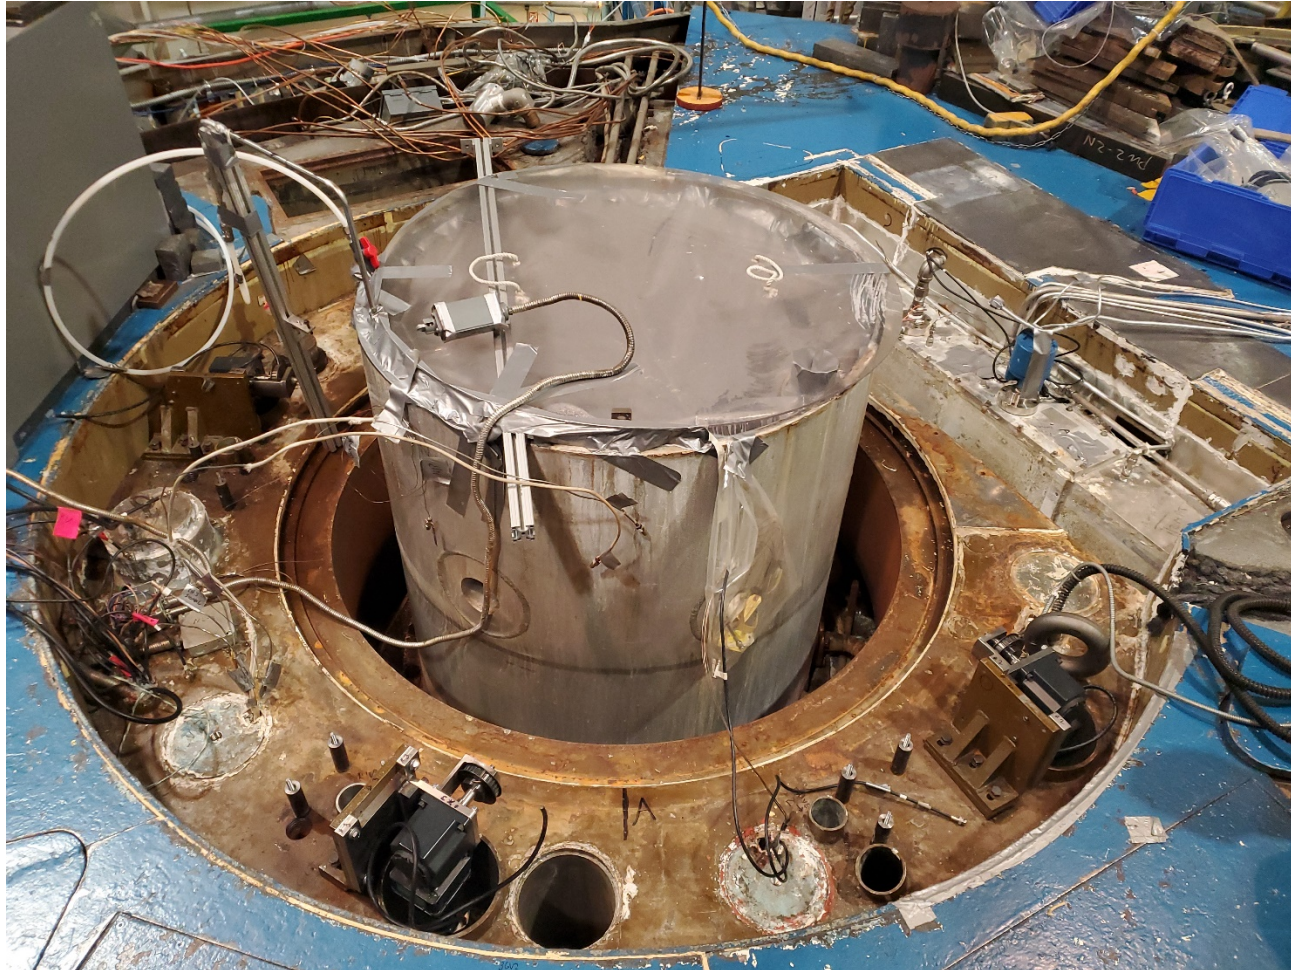
*Cabling & detectors removed*

# Disassembly Begins

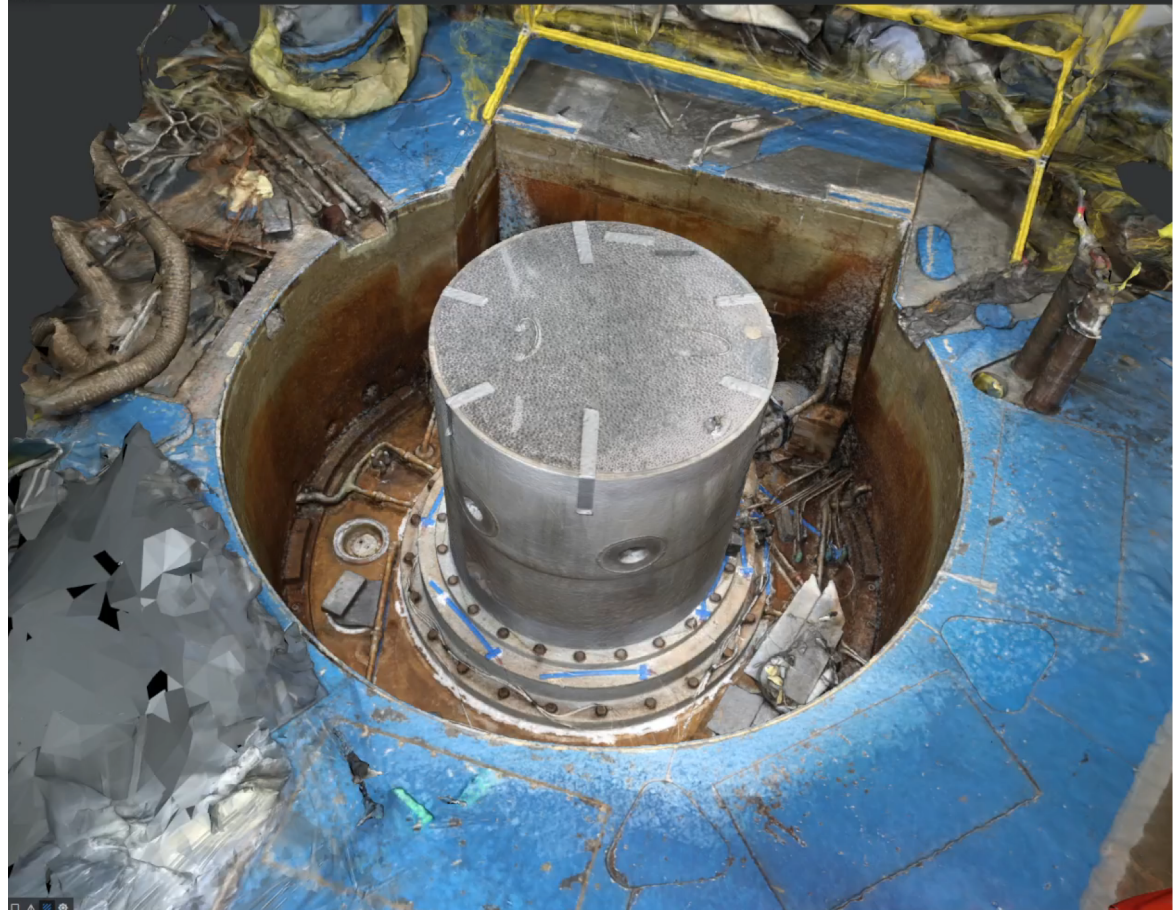
- Core De-Fueled
- Vertical Detectors, experiments, leak detection tapes removed
- Meters of cables removed
- Existing systems disturbed with ‘accelerated disassembly’
- 3D View of core tank with hardware removed [See 2023 TRT talk for more]

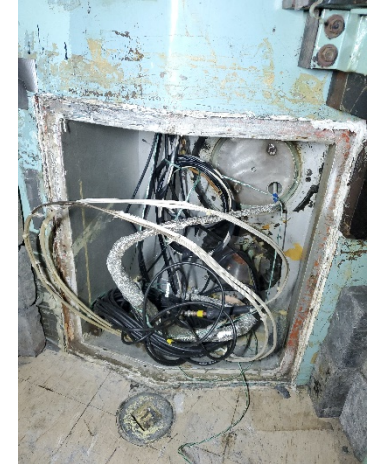
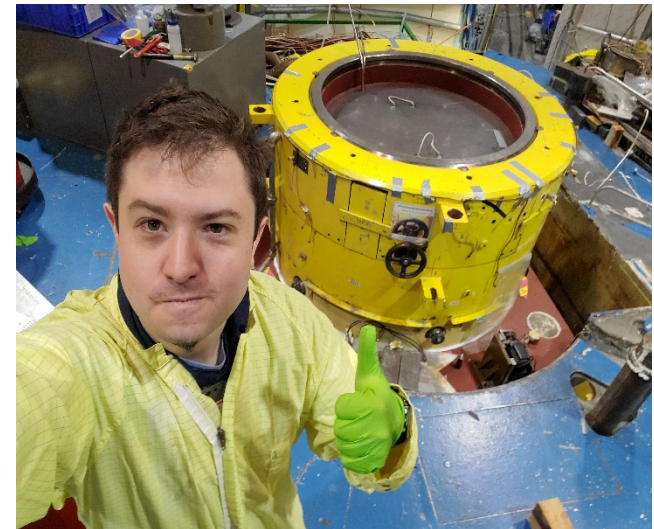
- Mechanical disassembly, leak identification and repair took months
- Meters of cables removed to aide in leak identification
- Existing systems disturbed with ‘accelerated disassembly’
- Re-cabling & Re-Terminating required for all of nuclear safety system

## ➤ New cables, new detector positions, what could possibly hinder restart?

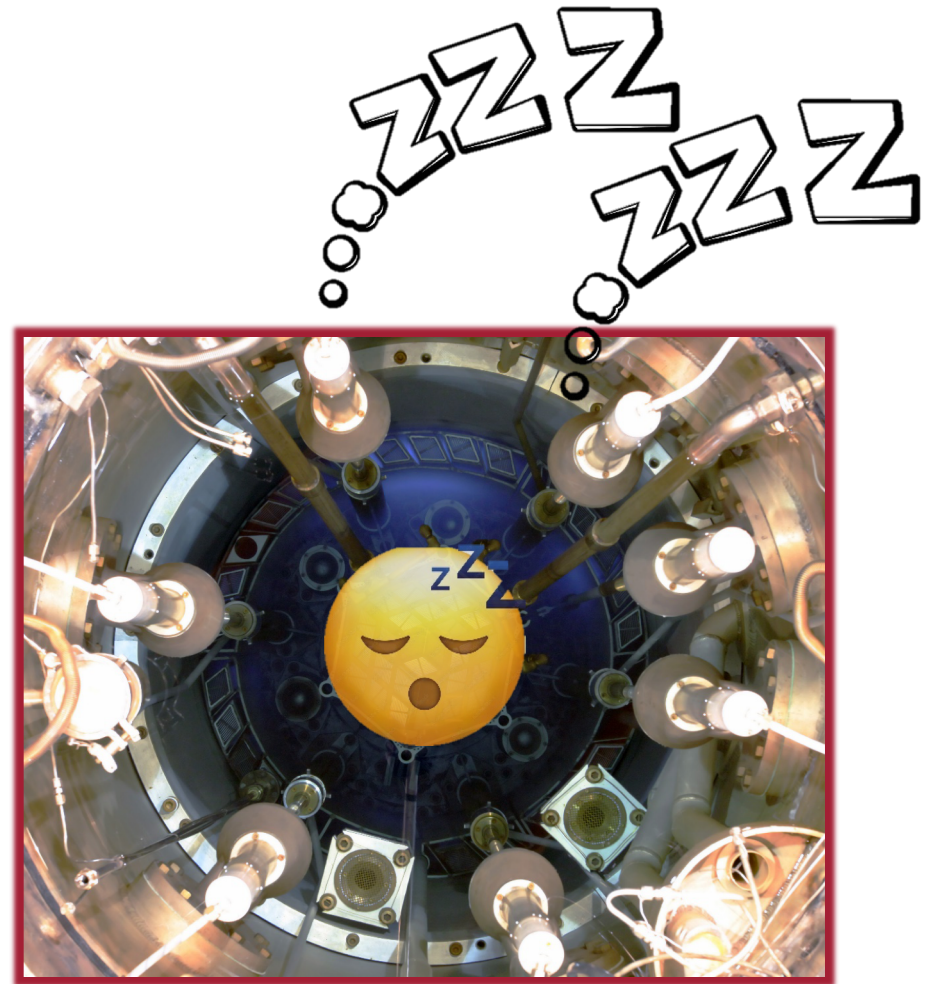
- Late 2023
  - Fuel daughter-product Neutrons nearly exhausted
  - Nuclear instrumentation issues begin!
  - Initial detector locations intended for neutron flux proportional to 6MW, required significant re-location
  - One detector failure due to MI Cable damage from re-location.

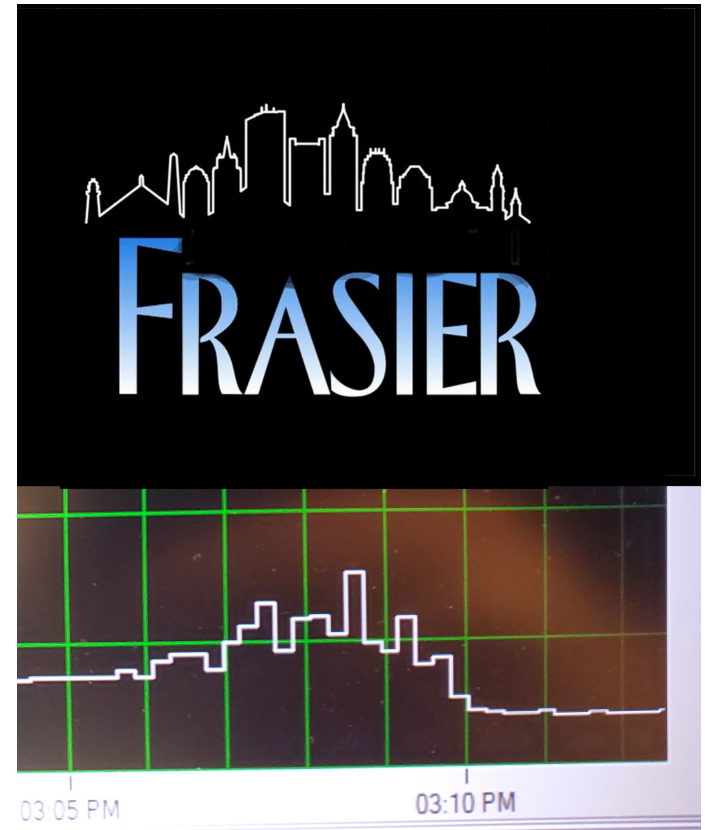
- Full Power Fission chamber Detectors re-located to closest to core position
- Temporary high sensitivity Helium-3 detectors installed to provide better indication of core status for re-fueling
- Apparent disconnect between reactor safety system count-changes and Helium-3 counts during reflector level changes & shutdown blade height changes

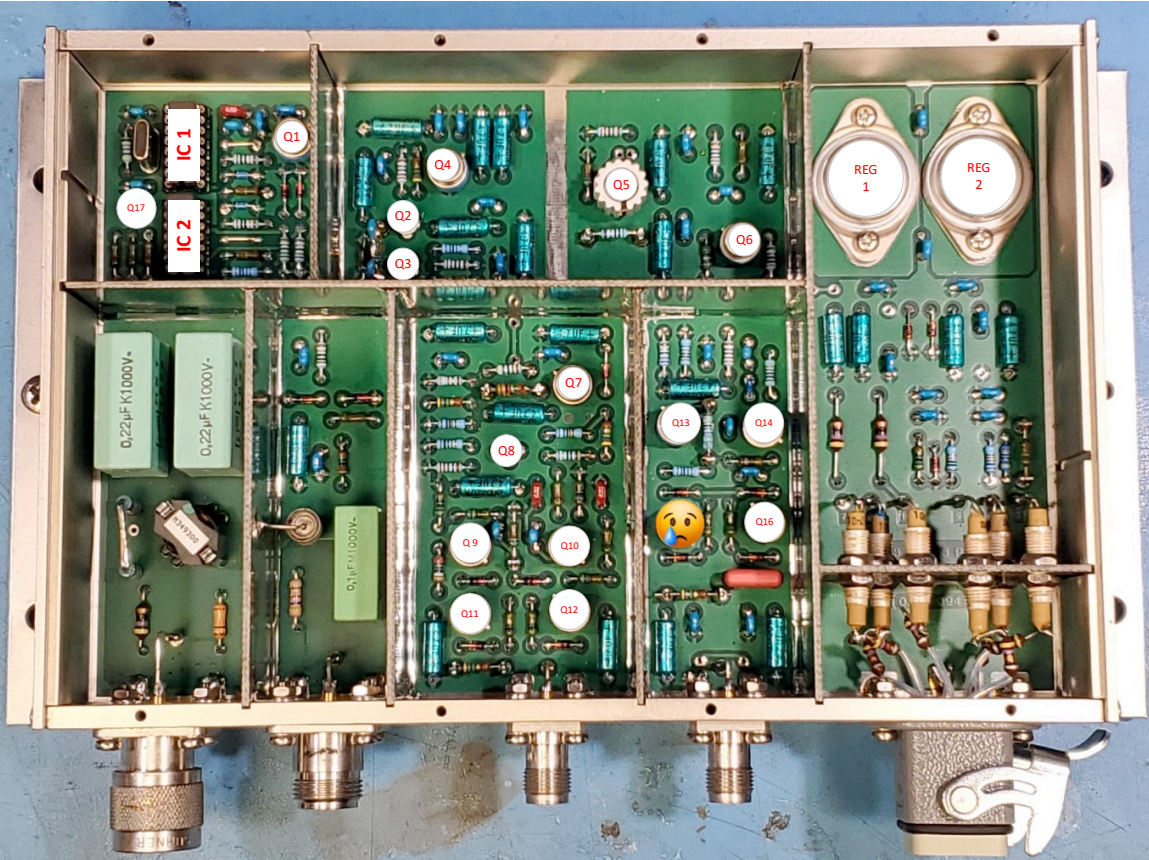
## ➤ Labeling and Beginning Diagnostics

- Pre-amplifier uses no component reference designators [R1, Q1, etc]
- A number of components are no longer manufactured
- Schematic & signal level repair unavailable

- Three pre-amps initially damaged during RX disassembly

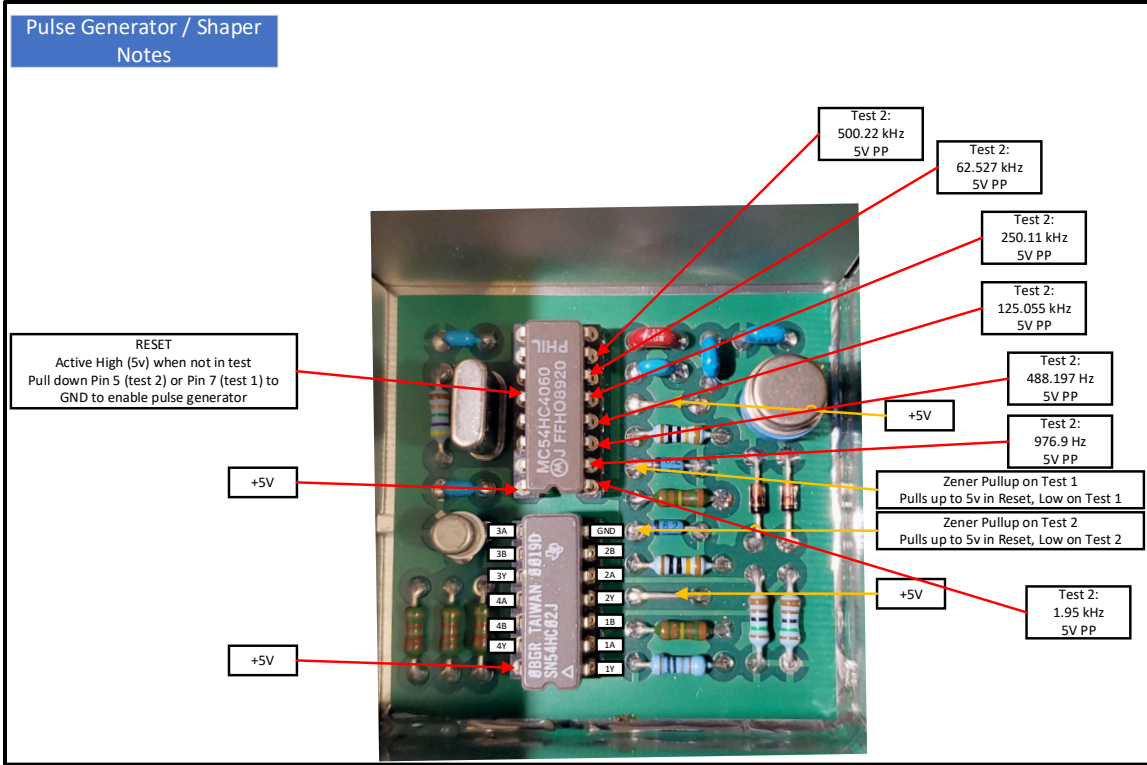
Pulse Generator / Shaper  
Notes

➤ Using one working unit to Identify component failures
