Corrective Action Program at NIST

Randy Strader

10/1/2024

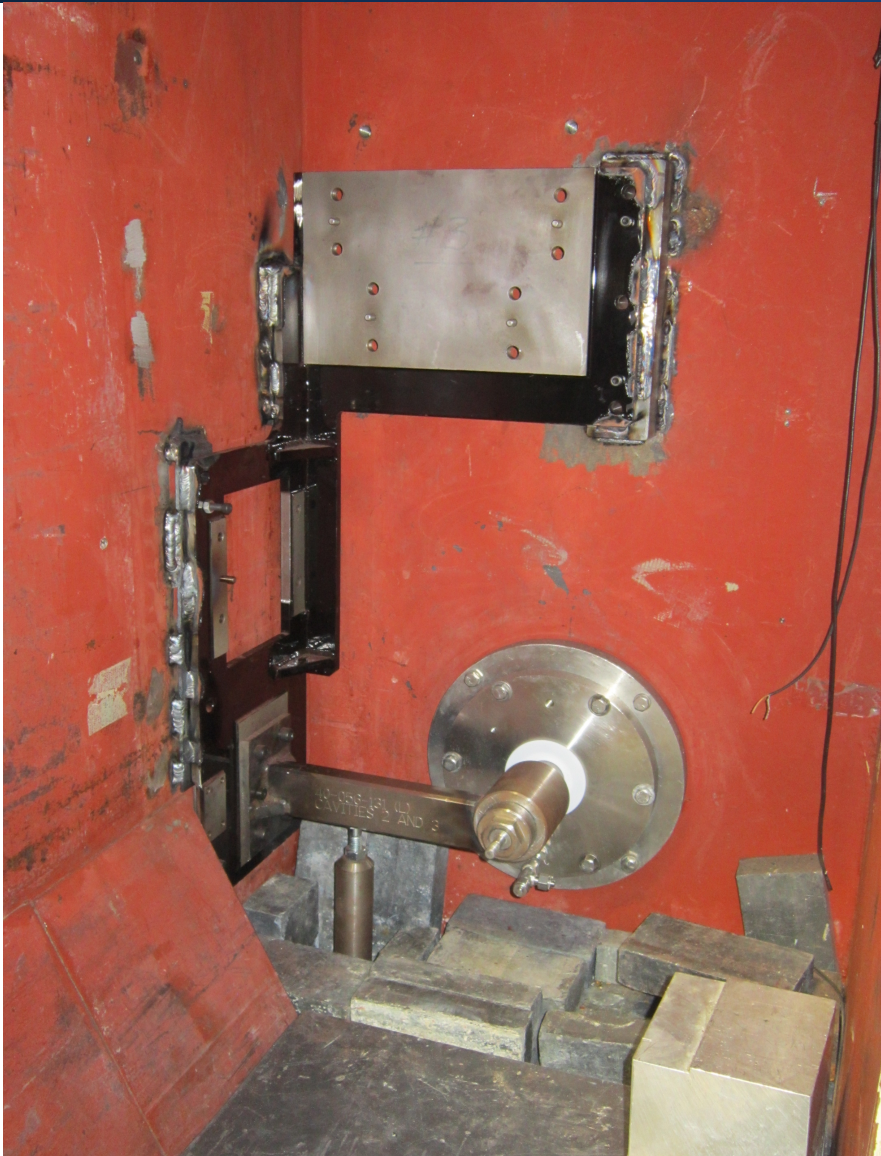
- Installation occurred during a 4-month outage in 2017
- Small teething issues during installation
 - Alignment issues with Shim Arm Shaft and Drive
 - Alignment issues with new position indication system
 - Loose contamination due to 40+ years of small primary leaks pass shaft seals
- In the end, all 4 shim arm drives passed prescribed testing
- Reactor successfully restarted in early 2018
