Diagnosing and Troubleshooting Successive Fission Chamber Failures

C. Corey Hines, Mathew D. King, and Donald E. Wall
Washington State University Reactor
Nuclear Radiation Center

Washington State University Reactor: Background

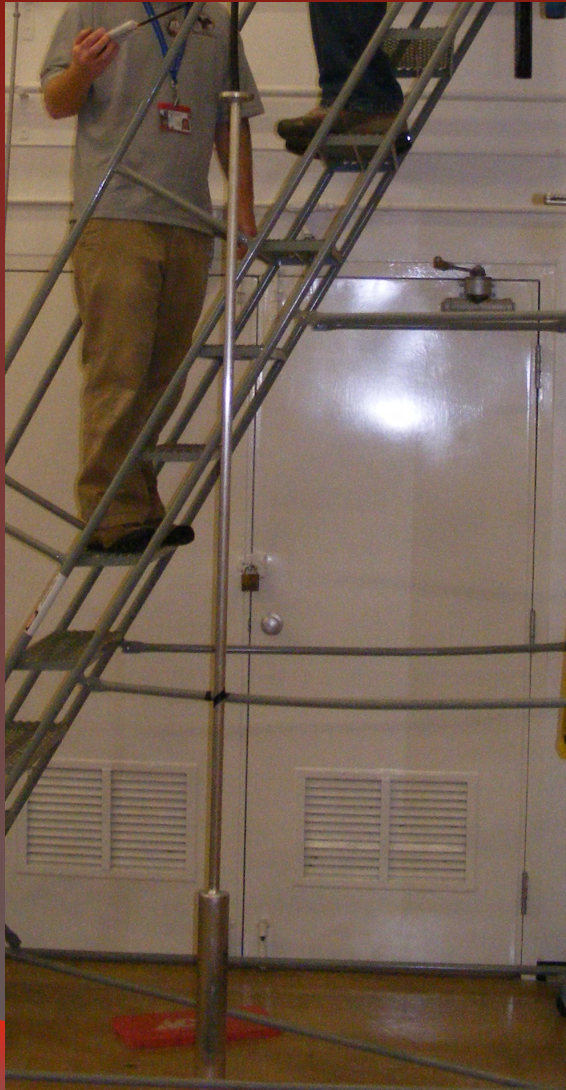
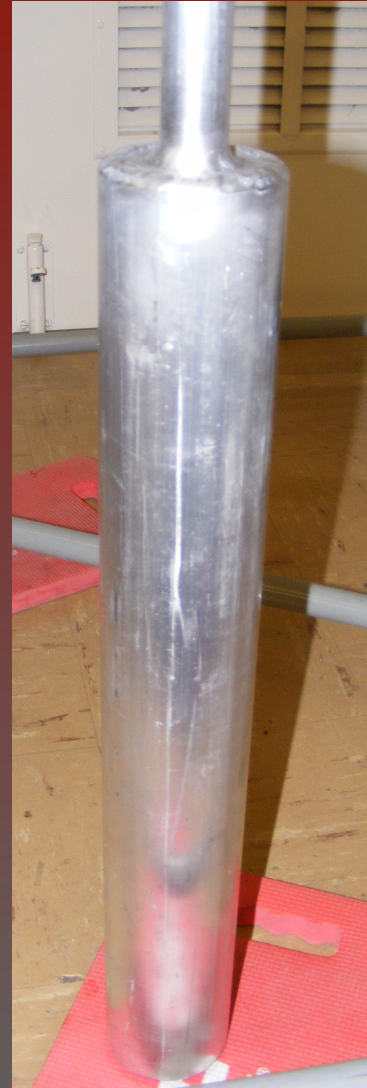
Table 1. Detector as received, with poly insulator around detector center wire

Detector	Detector+cable
DVM	resistance (Ω)	2.47E+08	N/A
	capacitance (pF)	230	N/A
electrometer HPS +	voltage 1 (V)	200	200
	voltage 2 (V)	800	800
	current 1 (A)	1.49E-07	1.49E-07
	current 2 (A)	1.50E-07	1.50E-07
	resistance (Ω)	6.00E+11	6.00E+11

- OSU Reactor donated a fission chamber.
- GA sent detector cabling and insulation materials.
- Local shop fabricated detector can and performed chamber closure welds.
- Detector came with poly insulator that was replaced with teflon insulator milled in house.
