OPAL Reflector Vessel & leak mitigation

RVE He Leak Test - Method

RVE He Leak Test - Results

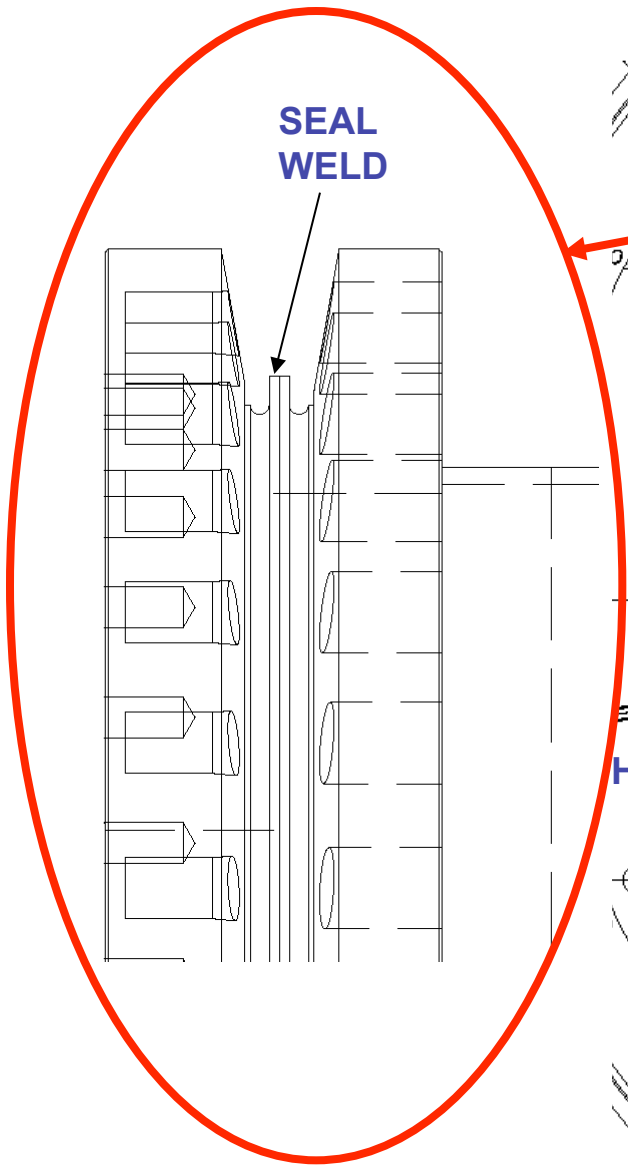
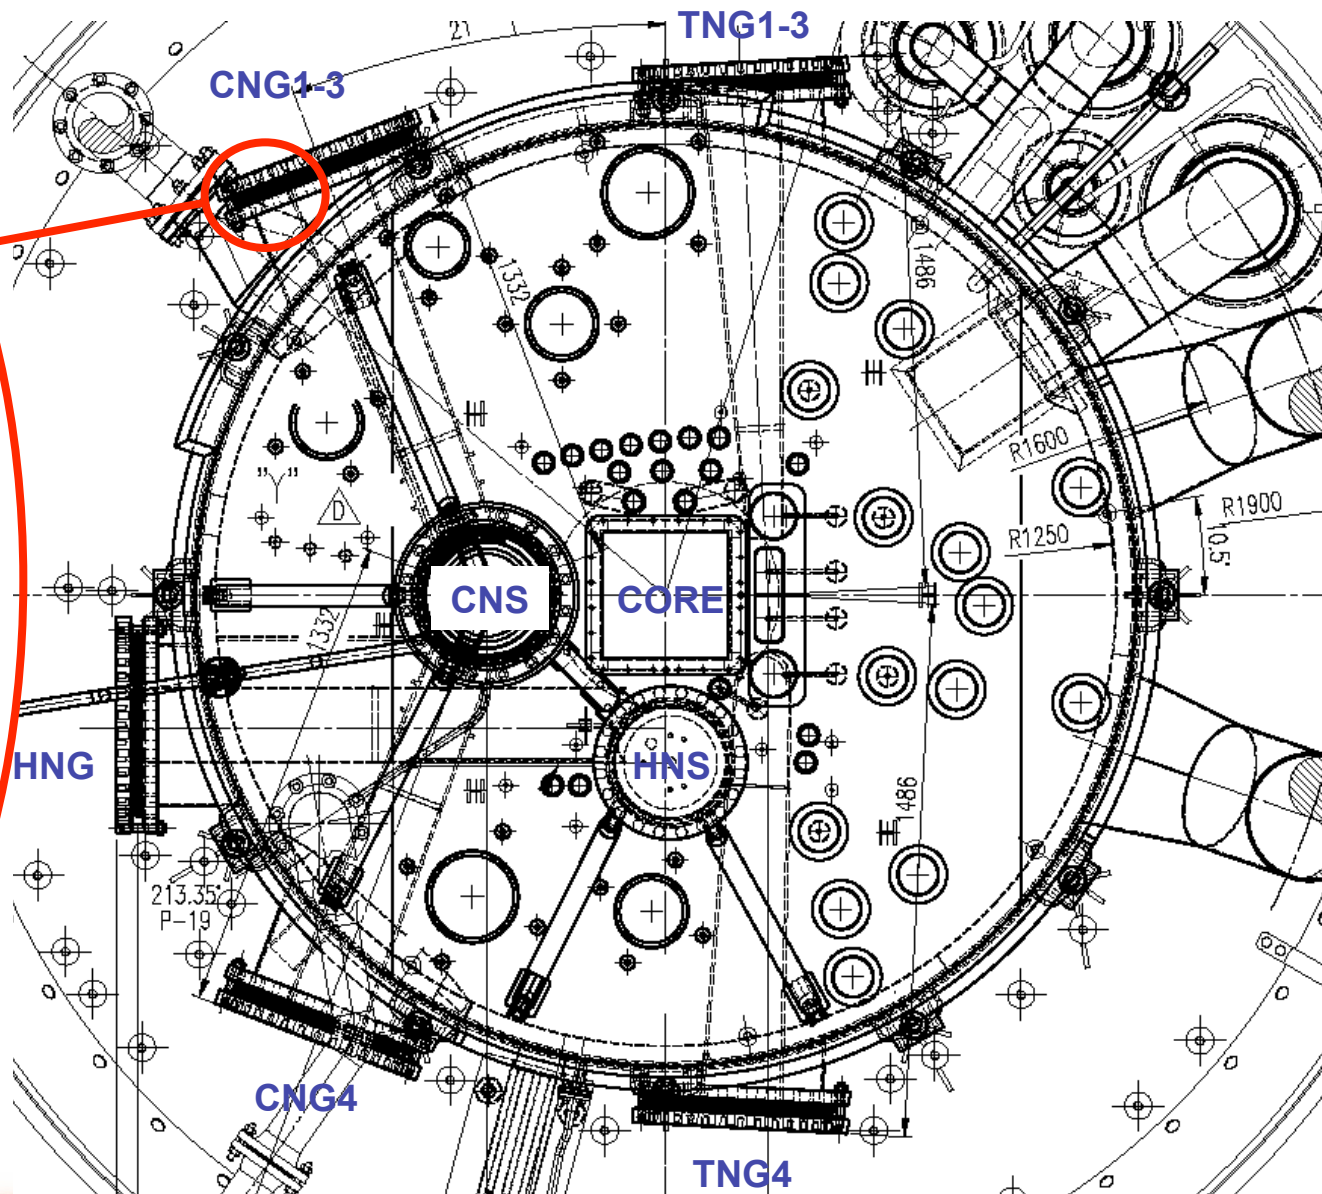
- First helium bubbles were observed 3 hours into the test from the TNG1-3 flange
- Smaller helium bubbles were observed on day 4 from CNG1-3 and TNG4
- No other leakages observed
- Collection of bubbles from the TNG1-3 leaks showed a leak rate consistent with the isotopic purity degradation

**1 small leak
(~2.5%)**

**6 Leaks comprising
~95% of leakage**

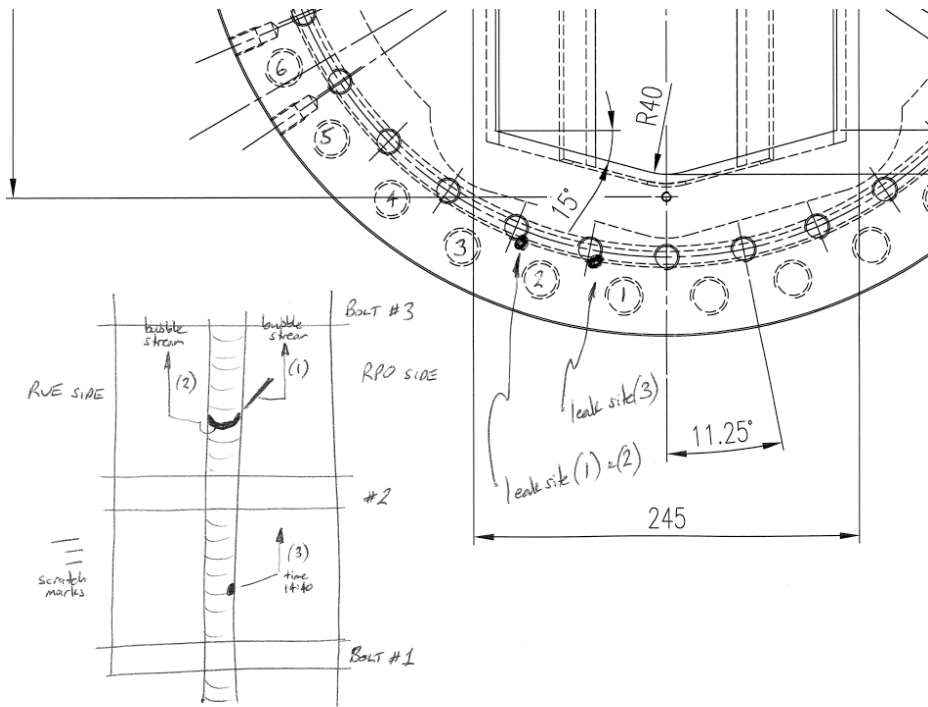
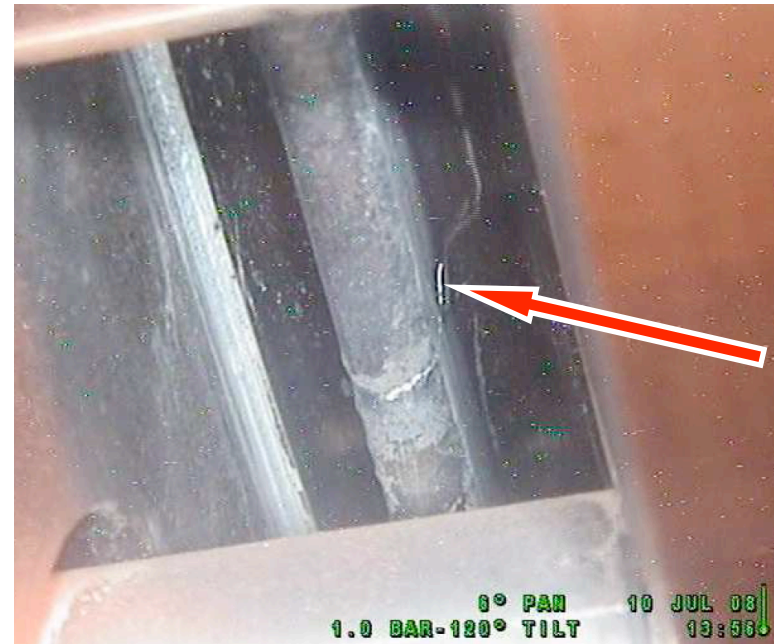
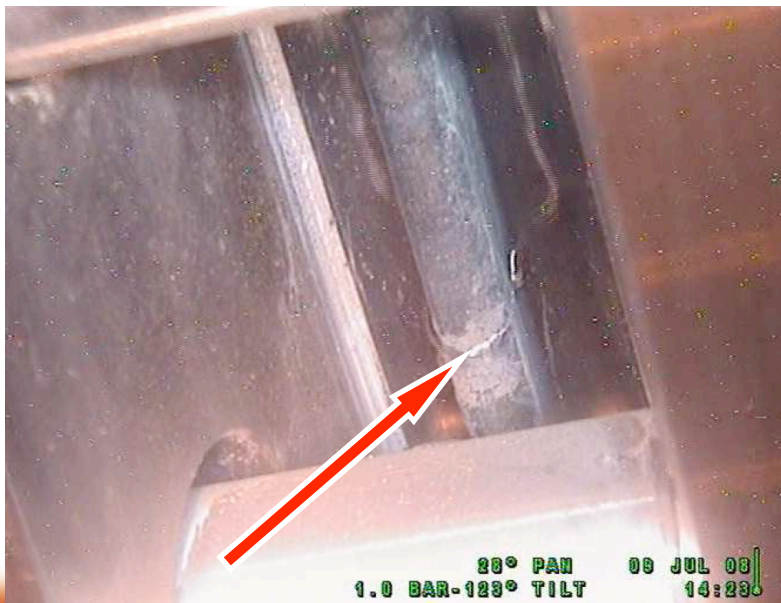
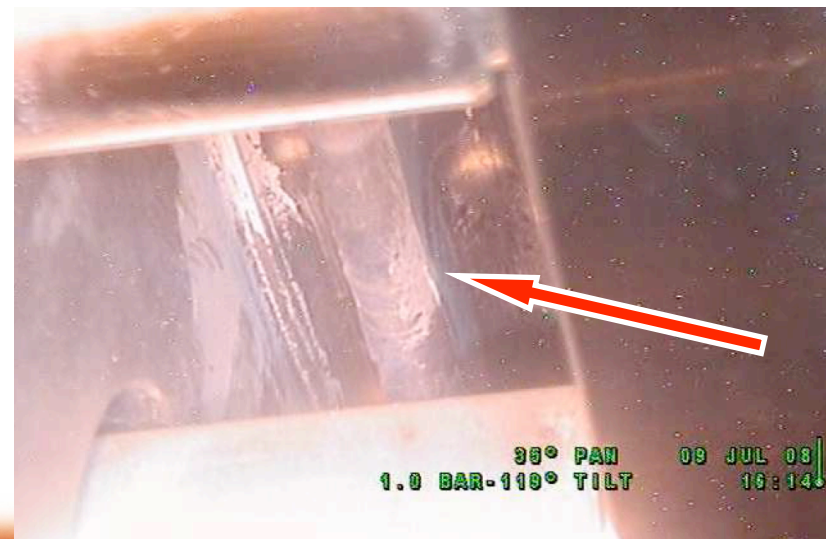
- No new leak sites identified
- Estimated leak site diameter ~20 micron.
- Estimated leak site length of 20-200 micron.
- Temperature effect may be due to variation in water viscosity
- Alumina injection now largely ineffective
