AN APPROACH TOWARD IN-CORE DETERMINATION OF POSSIBLE FUEL ELEMENT CLADDING RUPTURE

Thomas Quirk, Lonnie Martin, Dave Vehar
Sandia National Laboratories
P.O. Box 5800
Albuquerque, New Mexico 87185

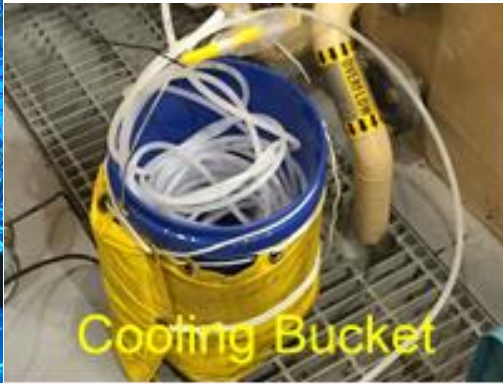
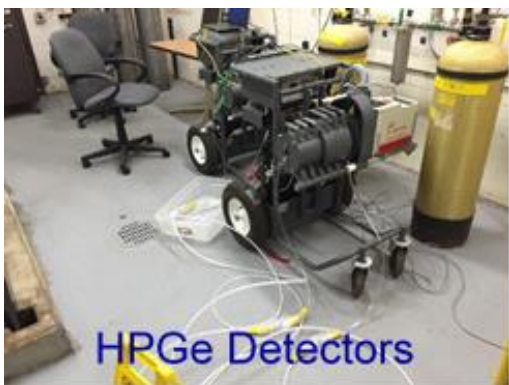
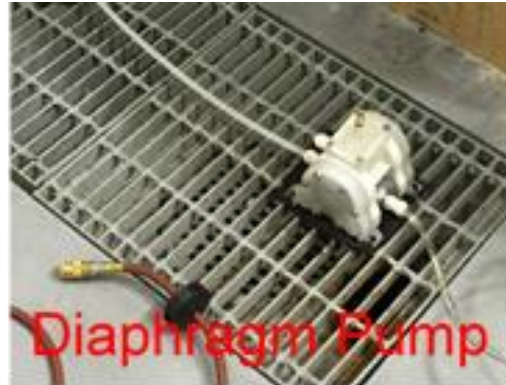
Elements of the Sipping Tool

In an attempt to eliminate the possibility that fission product gasses were being vented or stripped out of solution while collecting the water samples, a similar method was engineered at ACRR to allow water to be pumped directly from the near-core sample location, to a tubing coil around a HPGe detector in an adjacent, lower radiation background room. Images below show elements of this system.

The heart of the system is a mobile gamma spectroscopy cart (Canberra's ISOCs system) with a portable, electrically-cooled HPGe that can be pointed in various orientations and modular lead shielding. The annulus between shielding and detector was tightly coiled with tubing. As shown in the above image, the detector was turned parallel to the ground to minimize the impacts of any leaking water. The detector efficiency was modeled as a solid ring of water lined with tubing walls surrounding the detector. To cool the hot water coming directly from the core, water was first pumped into an ice bath. This had an additional benefit of permitting the N-16 normally present in the water during reactor operations to decay before coming near the detector. Specific locations at any height in the pool could be sampled with little or no dilution effect and the reactor could be operated at power while sampling was occurring. Two detectors were used to allow for simultaneous sampling of two locations.
